## Acme Township VGT Development

### Storm Water Run-Off

October 14, 2014

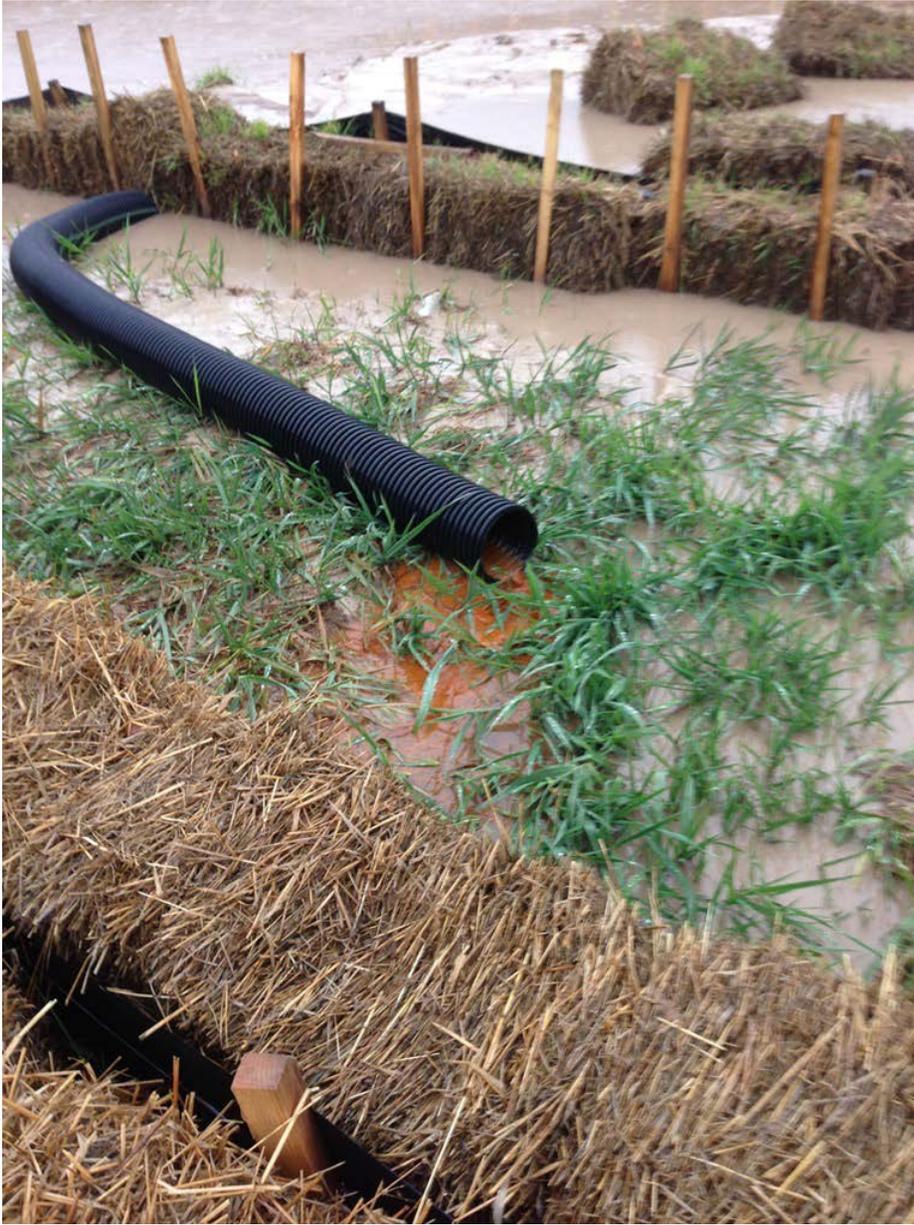
The second discharge noted was at the wetland low area located between the east and west basins. The soil stockpiled along the south side of the site road has not been stabilized yet. Water pools at the base of the soil pile at the top of the wetland. Water is contained by silt fencing and two rows of straw bales. However, the water volume was over topping the silt fencing and first row of straw. It then was flowing under the second straw and creating a stream flow of water with silt into the wetland.

Containment at wetland

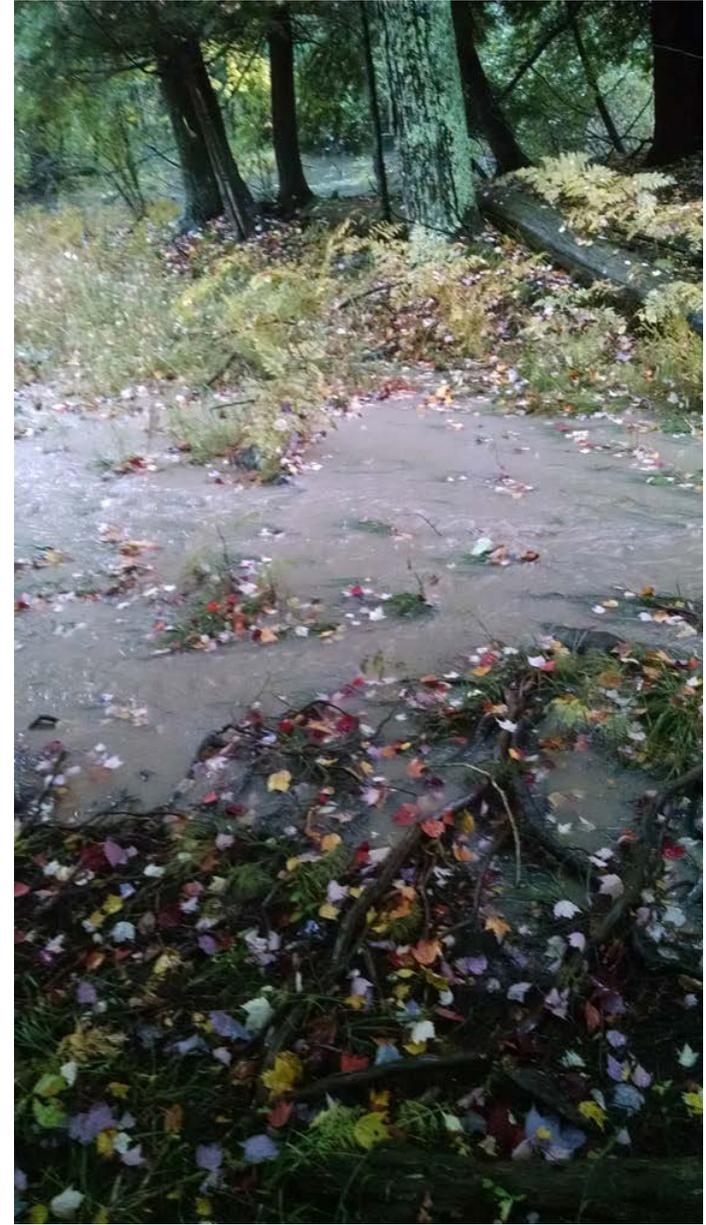
In addition, Bernie Jacobson observed a discharge to Acme Creek at the southeast corner of the site. Silt fencing at this location did not appear to be properly toed in.

Discharge stream from SE corner of VGT to Acme Creek

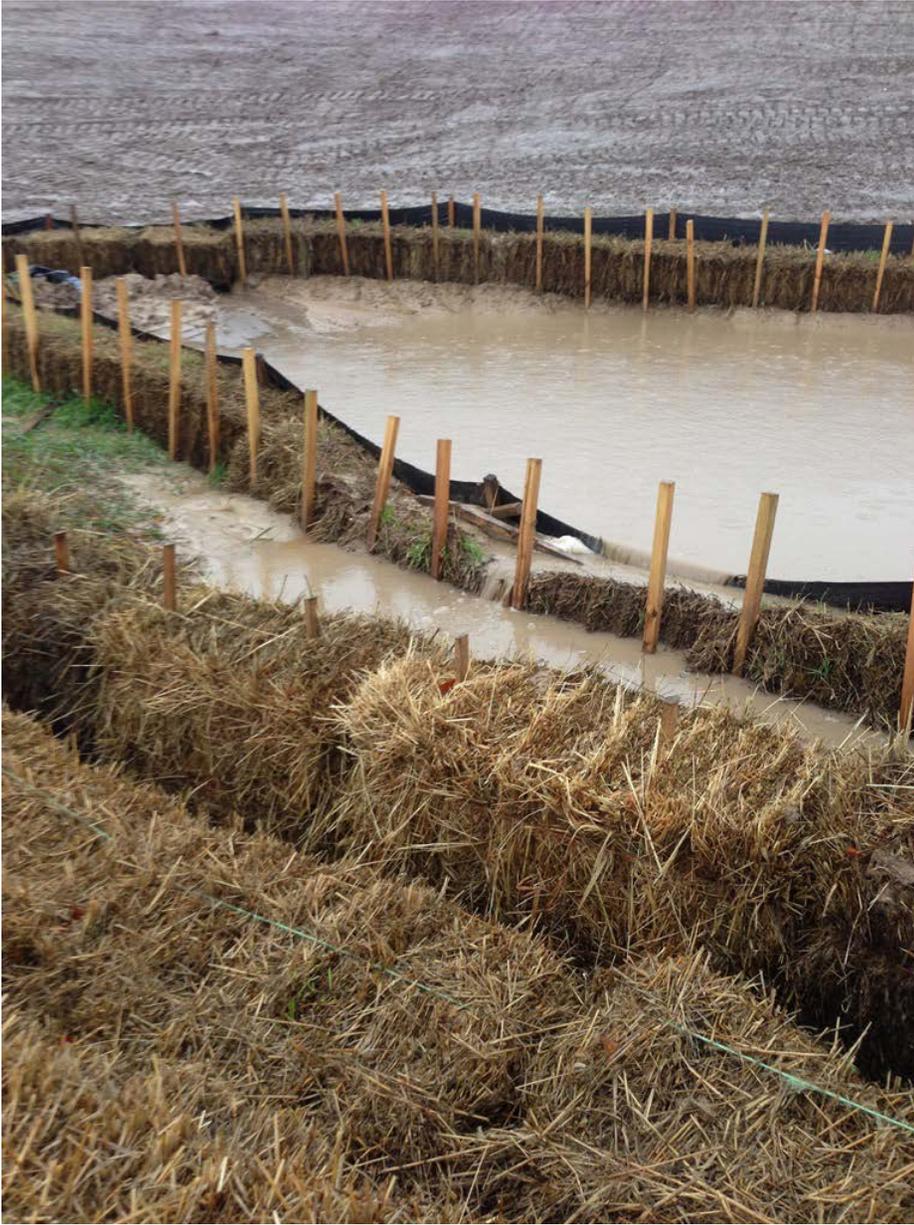
Over topping silt fence and first straw at wetland area

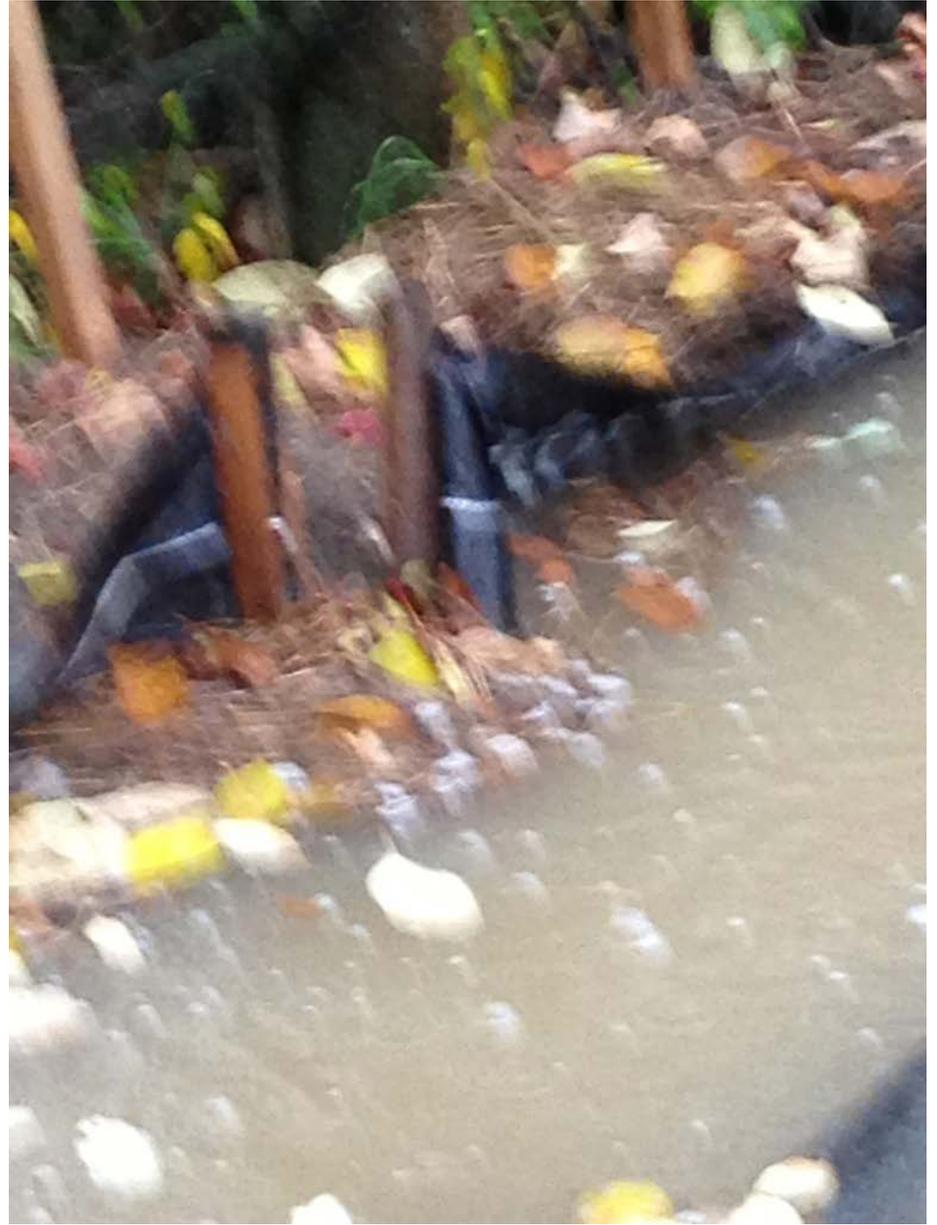
Separated silt fence at end of West Basin VGT

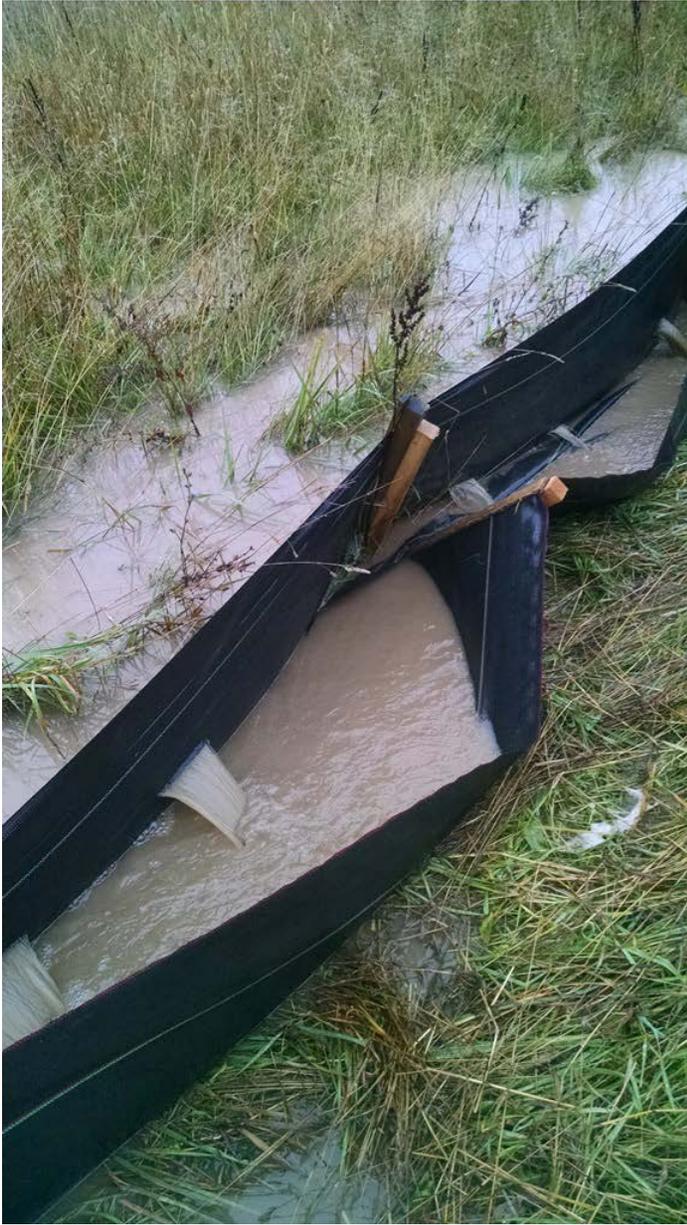
Silt fence at SE corner of VGT site

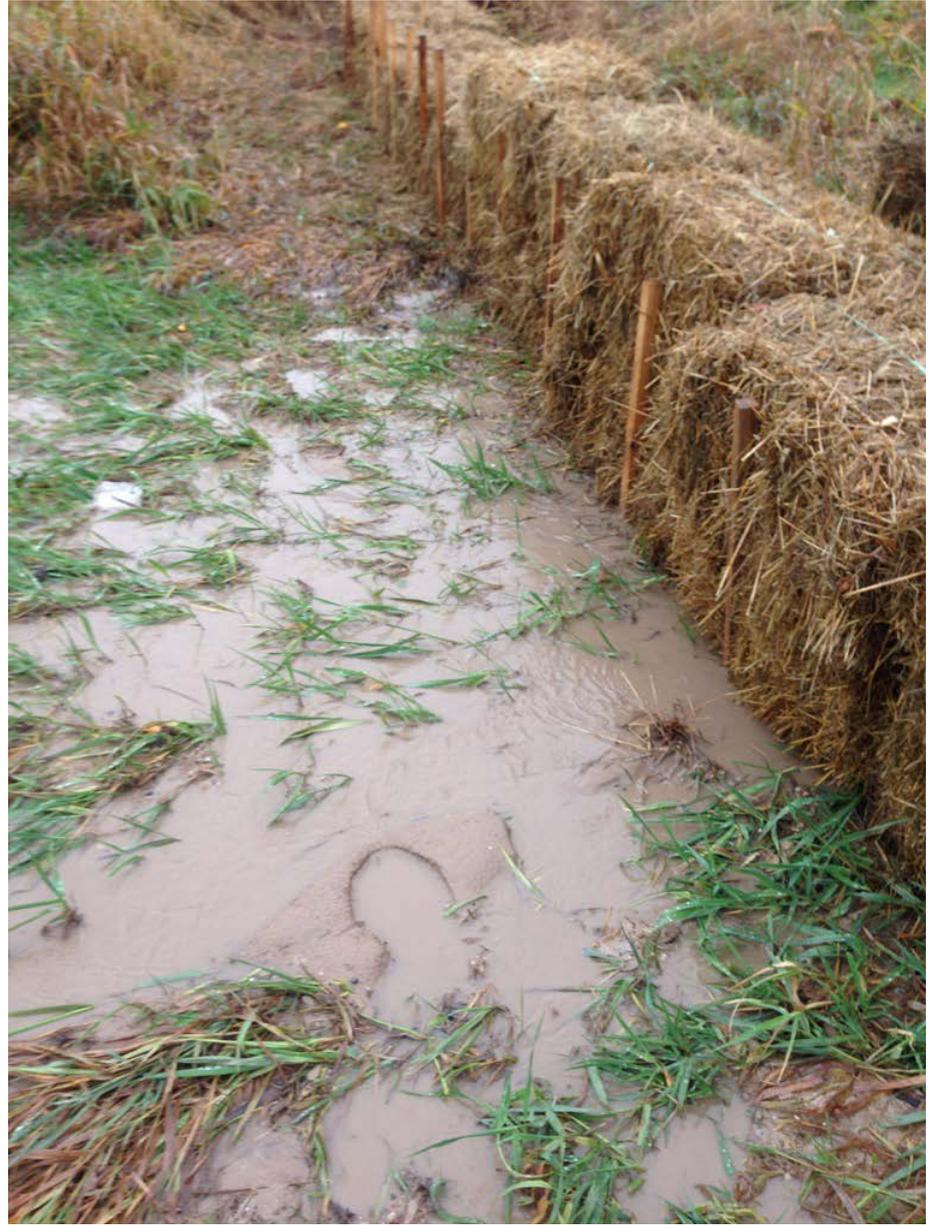
Underflow of second straw at wetland
