Grobbel Environmental & Planning Associates

November 10, 2014

RE: Review of Stormwater Management and Soil Erosion Control Measures, GTTC/VGT, M-72 Highway, Acme Township, Grand Traverse County, Michigan from November 7, 2014 Site Visit.

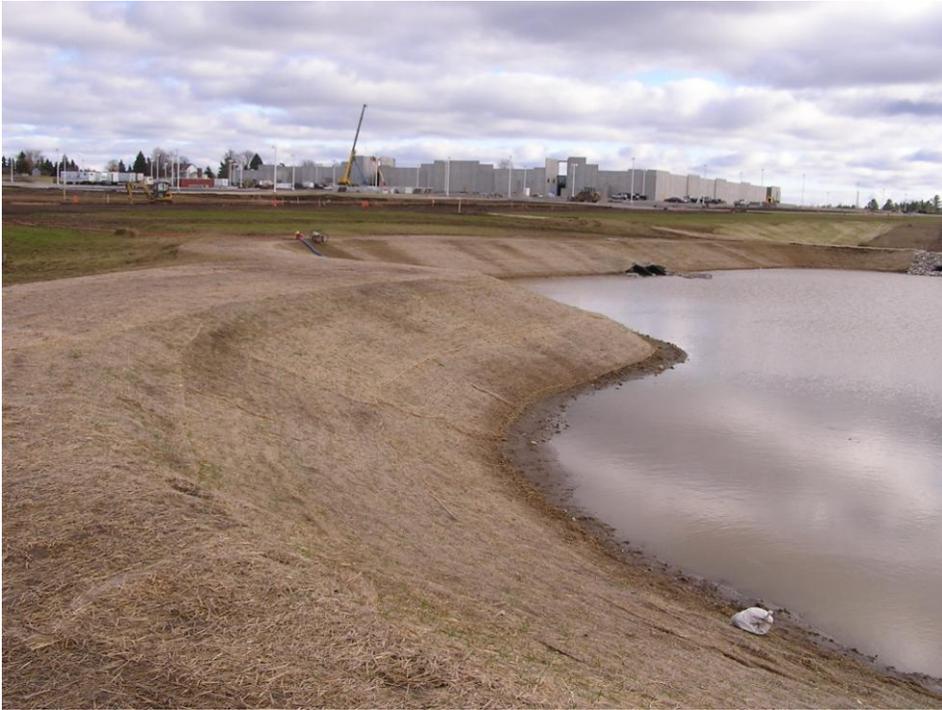
- 1) **Storm Water Retention Basin #1 – South-central Portion of the GTTC/VGT Site** – As shown in Photographs #1 through #7 below, stormwater detention Basin #1 (i.e., the southern basin) slopes remain unstabilized with an estimated 5% to 10% of grass/cover crop seed germination at the basin berms. *See Photographs #1 and #2 below.* It is recommended that additional seeding be completed as soon as practicable to protect system components, down slope wetlands and Acme Creek. Basin #1 was observed to be discharging stormwater during the November 7, 2014 site visit, despite the placement of a plug within the culvert outlet. *See Photographs #3 and #4 below.* Stormwater within Basin #1 was noted as being very cloudy, while stormwater discharge was observed to be running clear. A trash pump was placed at the north end of Basin #1 on this date to pump stormwater from Basin #1 to Basin #2. *See Photograph #1 below.*

Photograph #1: Basin #1, south-central portion of the GTTC/VGT property looking northeasterly at the basin and berm and showing that berm is ~5 to 10% vegetated. Taken by C. Grobbel, Grobbel Environmental & Planning, November 7, 2014.

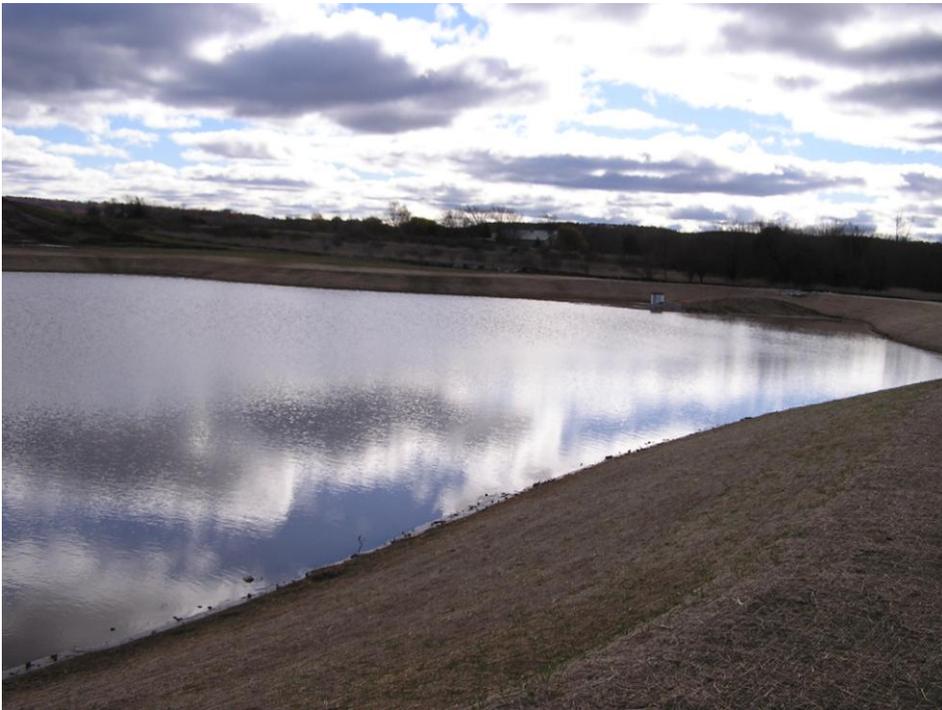
Of concern is the rip rap structure at the terminus of the grassed waterway conveyance from Basin #1 that had a gap in new silt fences on November 7, 2014 – precluding any meaningful sediment retention value. *See Photographs #6 and #7 below.* The discharge elevation within the Basin #1 outfall structure remains of concern which allows for stormwater pass through without retention within a majority of Basin #1's capacity, and is deemed incompatible with the required construction of wetlands at this location and/or the reconfiguration of Basin #1 in whole or in part to established the approved stormwater management plan.

Photograph #2: Basin #1, south-central portion of the GTTC/VGT property looking southeasterly at outfall structure. Taken by C. Grobbel, Grobbel Environmental & Planning, November 7, 2014.

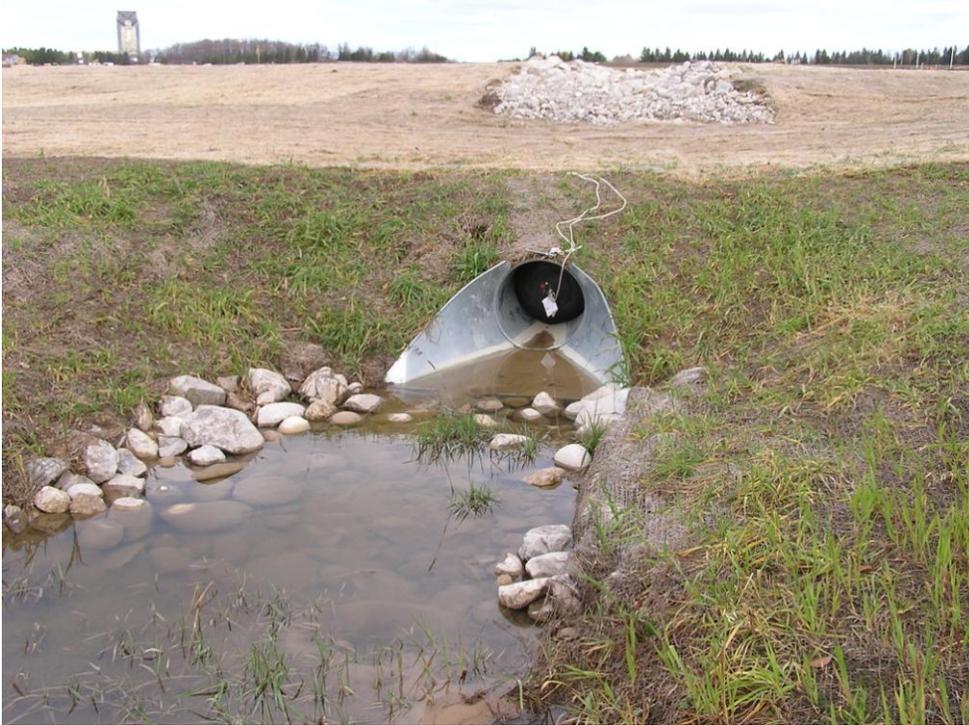
Photograph #3: south-central portion of the GTTC/VGT property looking northerly at plug within culvert outlet and showing clear stormwater discharge. Taken by C. Grobbel, Grobbel Environmental & Planning, November 7, 2014.

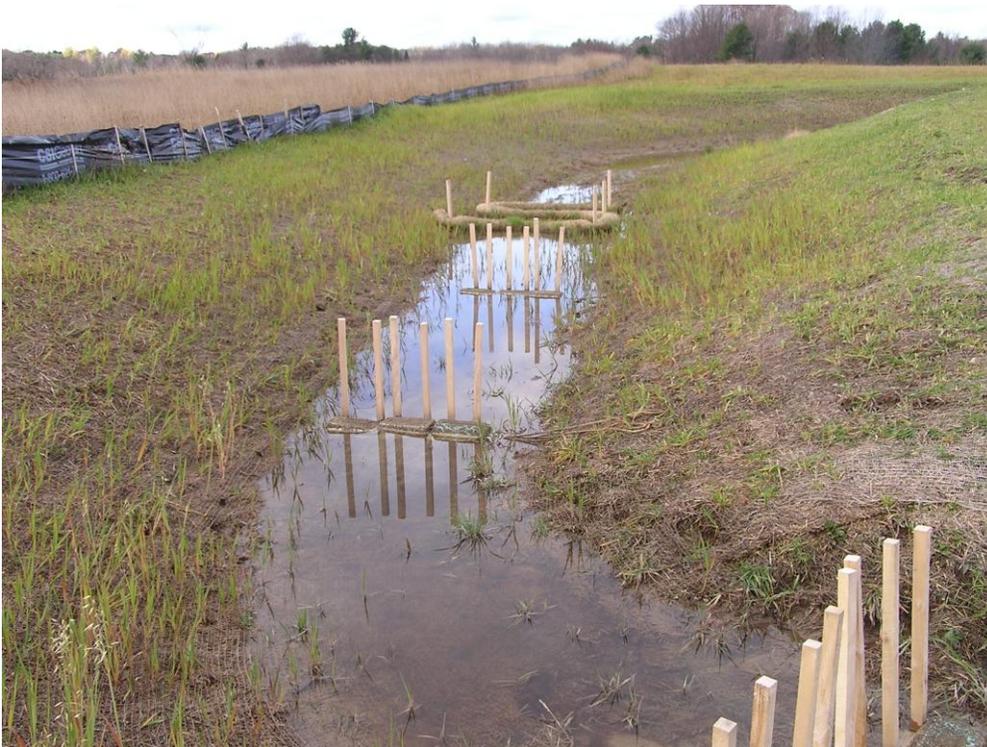
Photograph #4: Basin #1 discharge structure/grassed waterway, south-central portion of the GTTC/VGT property looking easterly and showing clear discharge/PAM flocculant blocks, waddle, and grassed waterway ~35 to 40% vegetated. Taken by C. Grobbel, Grobbel Environmental & Planning, November 7, 2014.

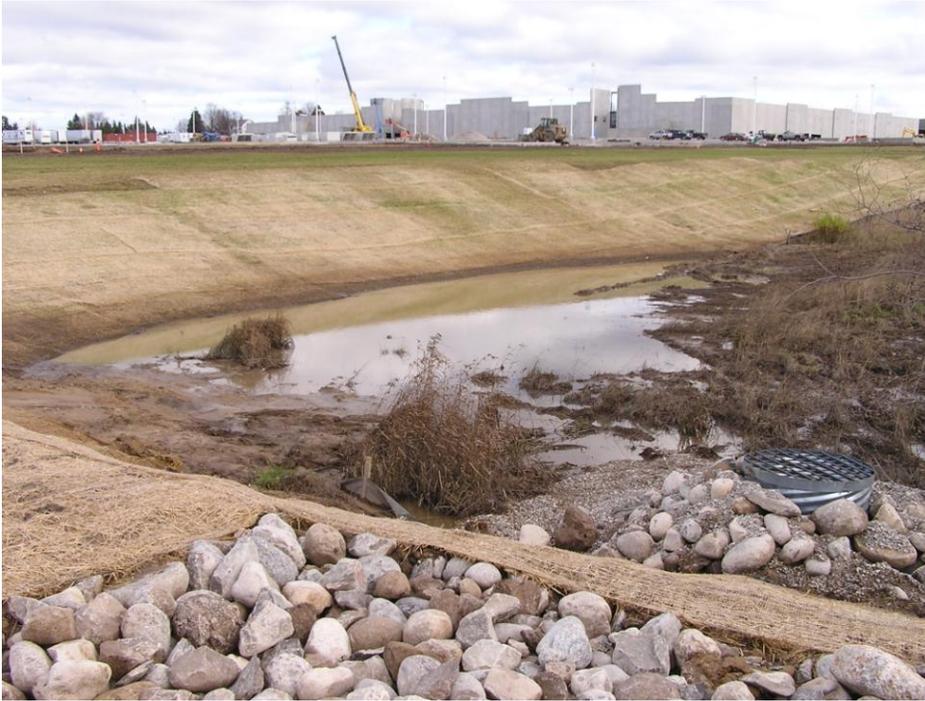
Photograph #5: Swale and discharge structure to Basin #1 south-central portion of the GTTC/VGT property looking north-easterly. Taken by C. Grobbel, Grobbel Environmental & Planning, November 7, 2014.

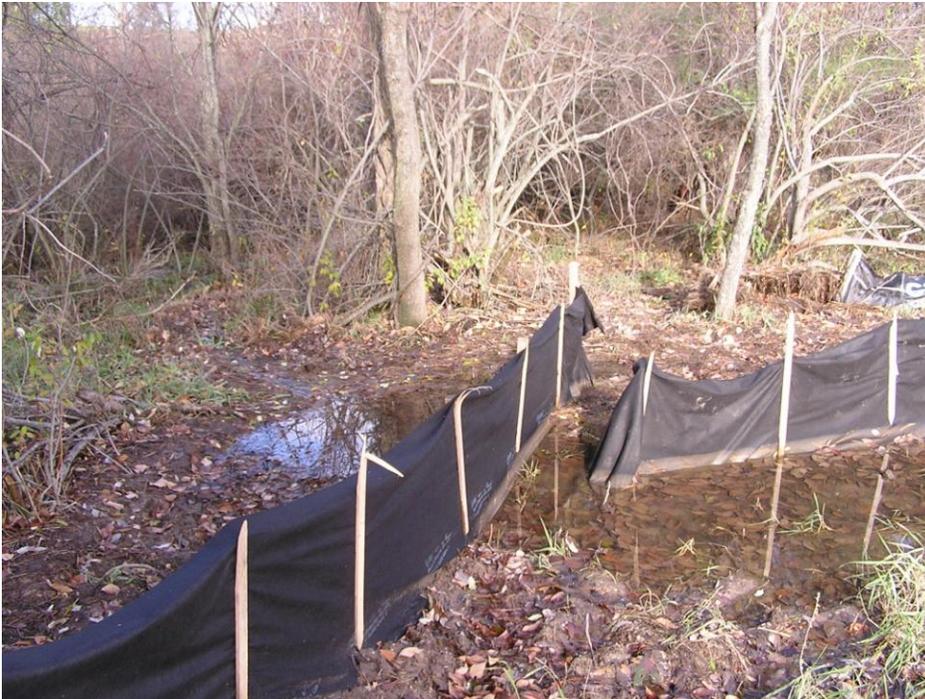
Photograph #6: Basin #1 discharge structure/grassed waterway terminus, south-central portion of the GTTC/VGT property looking easterly and showing gap in silt fences. Taken by C. Grobbel, Grobbel Environmental & Planning, November 7, 2014.

It is recommended that the terminus of the grassed waterway conveyance from Basin #1 be re-designed, re-constructed and maintained with numerous layers of sediment retention best

management practices (BMPs), such as exists at the terminus of the grassed waterway conveyance from Basin #2 and as shown below in Photographs #20 through #22 .

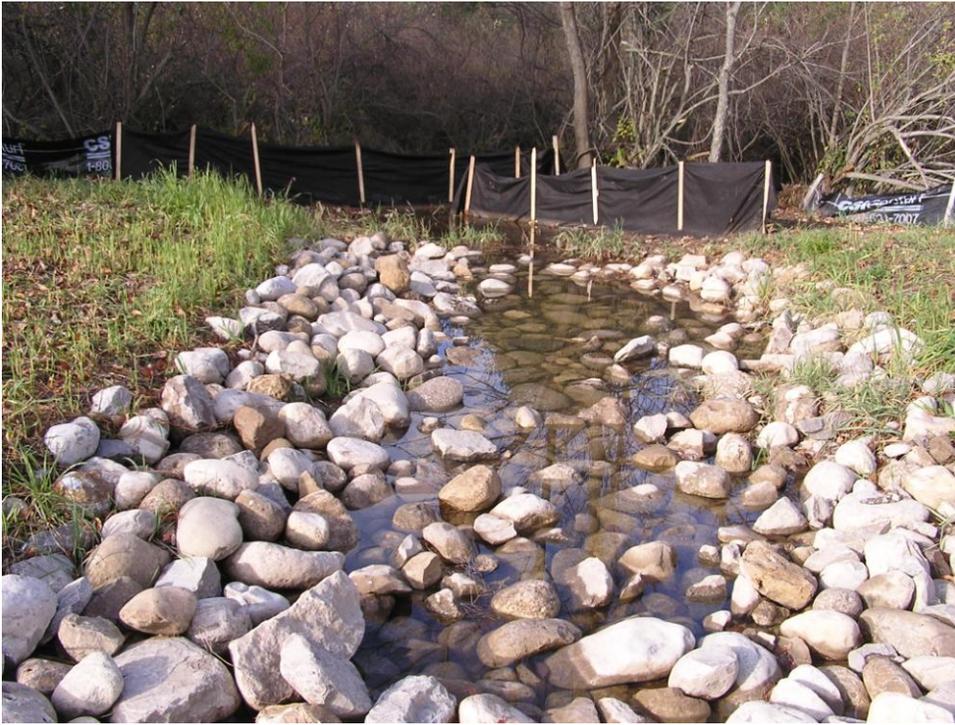
Photograph #7: Basin #1 rip rap discharge structure/grassed waterway terminus, south-central portion of the GTTC/VGT property looking easterly and showing gap in silt fences. Taken by C. Grobbel, Grobbel Environmental & Planning, November 7, 2014.

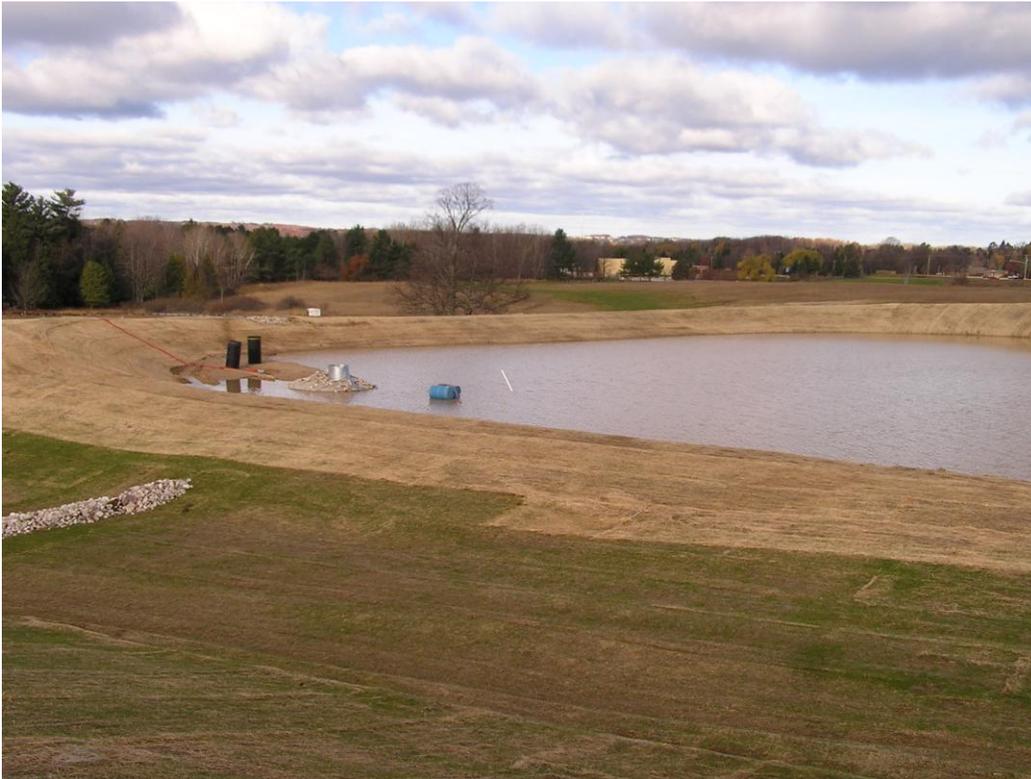
- 2) **Storm Water Retention Basin #2 – West-central Portion of the GTTC/VGT Site** – As shown in Photographs #8 through #10 below, stormwater detention Basin #2 (i.e., southwestern basin) slopes remain unstabilized with an estimated 5% to 10% of grass/cover crop seed germination at the basin berms. *It is recommended that stabilization of basin berms be completed as soon as practicable to protect system components and downstream wetlands and Acme Creek.*

Also, of continued concern is the discharge elevation within the Basin #2 outfall structure. The established elevation allows for stormwater pass through without retention within a majority of Basin #2's capacity, and is deemed incompatible with the required construction of wetlands at this location and/or the reconfiguration of Basin #2 in whole or in part to established the approved stormwater management plan.

Photograph #8: Basin #2, south-western portion of the GTTC/VGT property looking northwesterly at basin outflow control structure. Basin approximately full and showing cloudy retained stormwater. Taken by C. Grobbel, Grobbel Environmental & Planning, November 7, 2014.

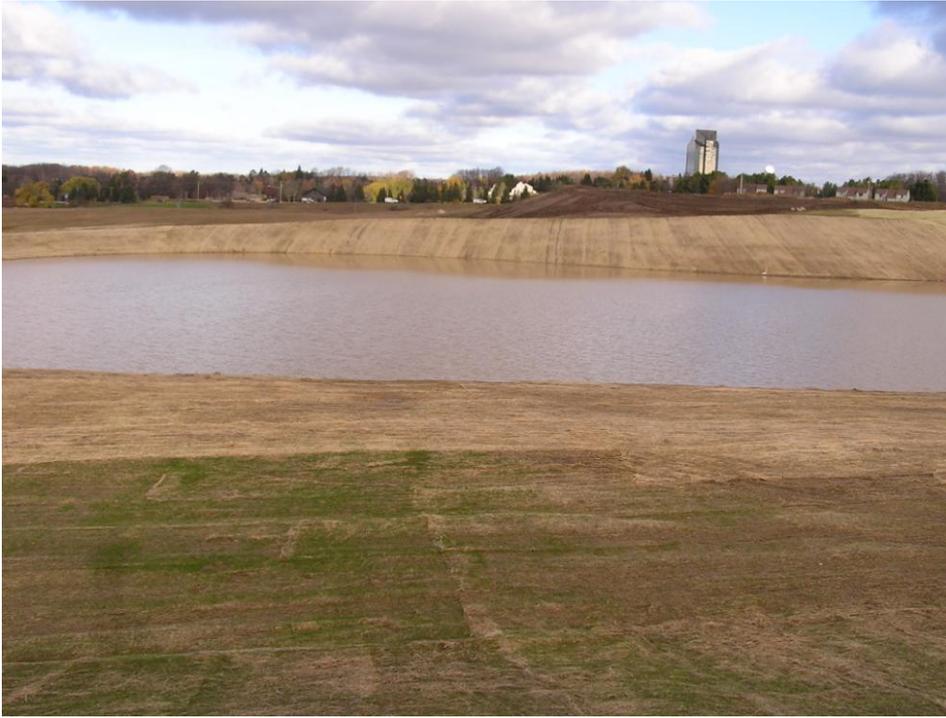
Photograph #9: Basin #2, southwestern portion of the GTTC/VGT property looking north-northwesterly at basin approximately full and showing cloudy retained stormwater. Taken by C. Grobbel, Grobbel Environmental & Planning, November 7, 2014.

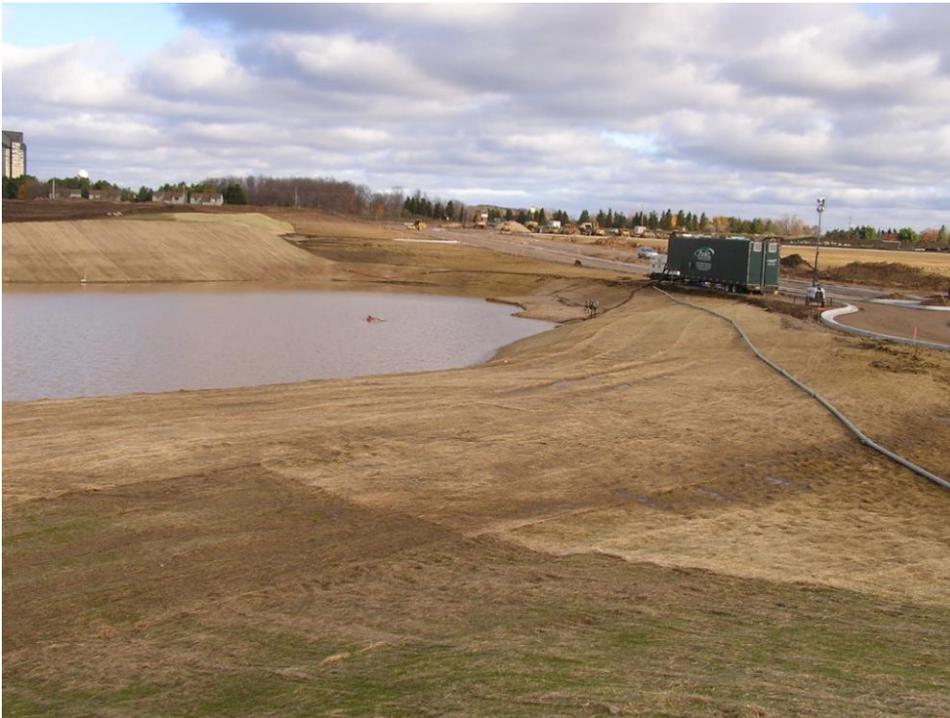
Photograph #10: Basin #2, south-western portion of the GTTC/VGT property looking north-northeasterly at basin approximately full, showing cloudy retained stormwater and mobile stormwater filtration/treatment unit. Taken by C. Grobbel, Grobbel Environmental & Planning, November 7, 2014.

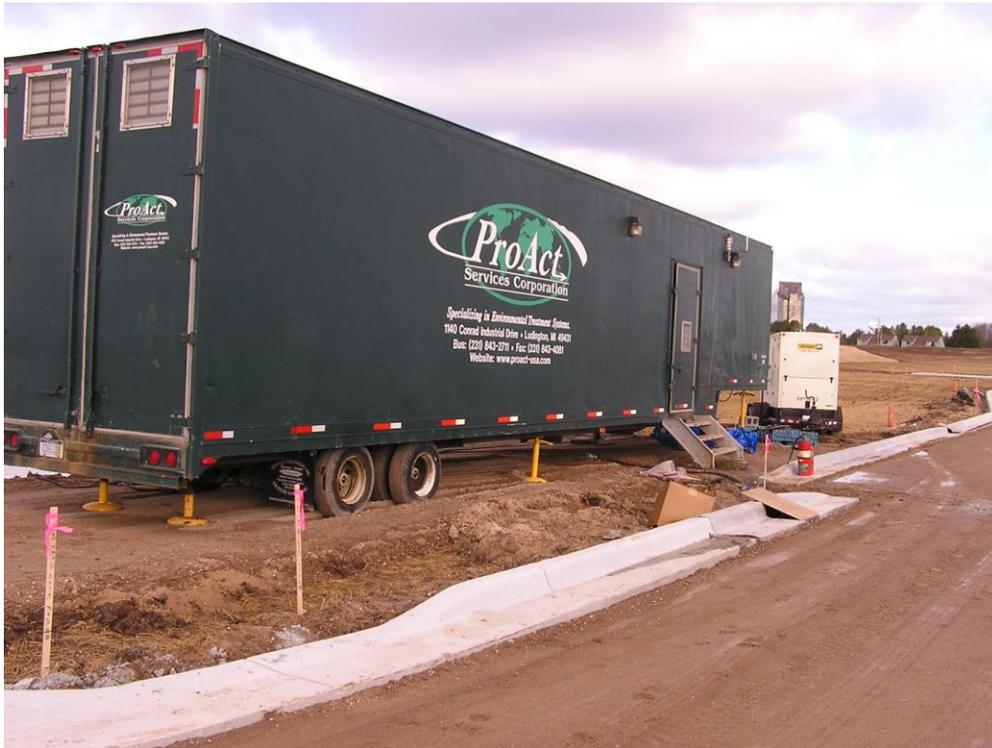
Photograph #11: Basin #2, south-western portion of the GTTC/VGT property looking north-northwesterly at mobile stormwater filtration/treatment unit. Taken by C. Grobbel, Grobbel Environmental & Planning, November 7, 2014.

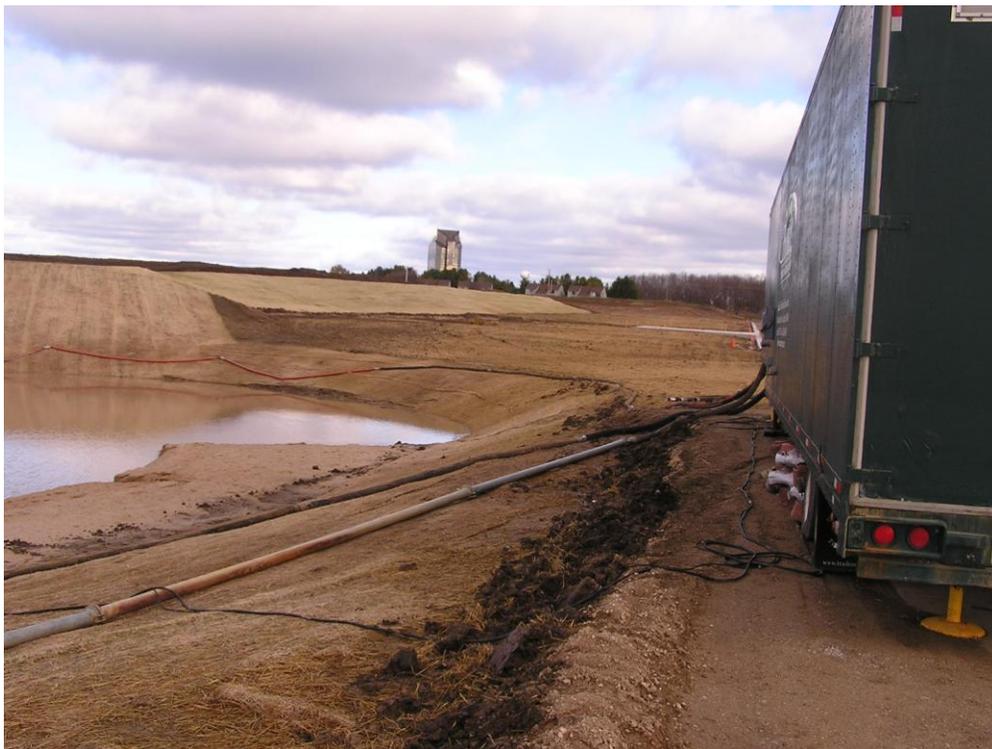
Photograph #12: Basin #2, south-western portion of the GTTC/VGT property looking northerly at basin approximately full, showing cloudy retained stormwater and mobile stormwater filtration/treatment unit intake and discharge hoses. Taken by C. Grobbel, Grobbel Environmental & Planning, November 7, 2014.

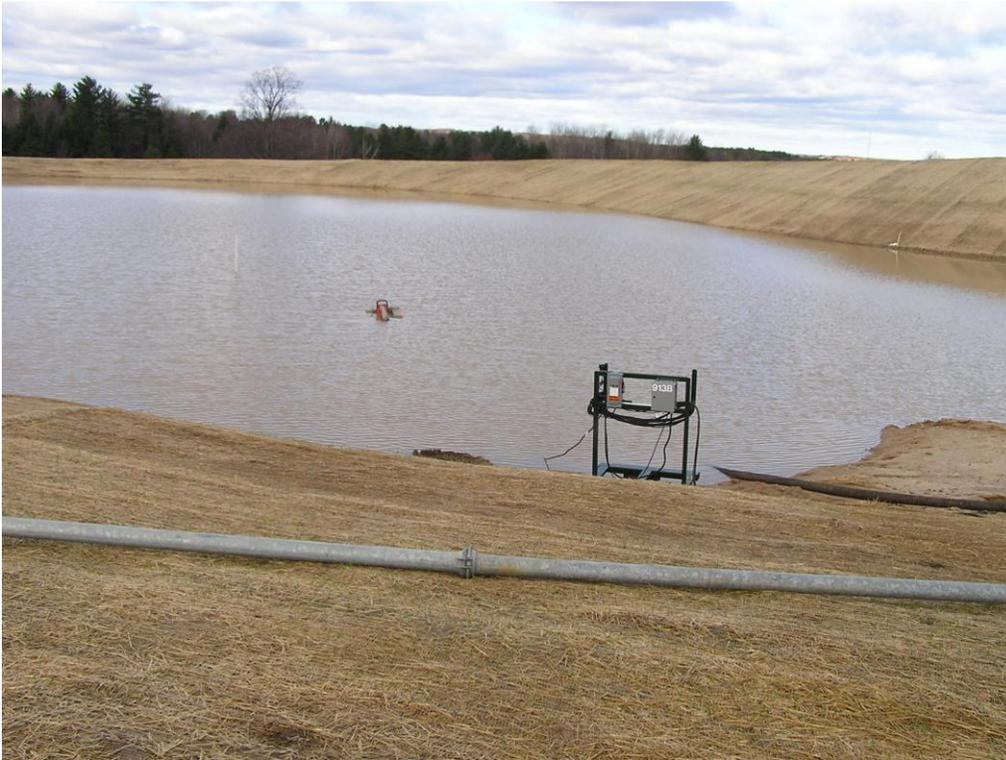
Photograph #13: Basin #2, south-western portion of the GTTC/VGT property looking northwesterly at basin approximately full, showing cloudy retained stormwater and mobile stormwater filtration/treatment unit intake. Taken by C. Grobbel, Grobbel Environmental & Planning, November 7, 2014.

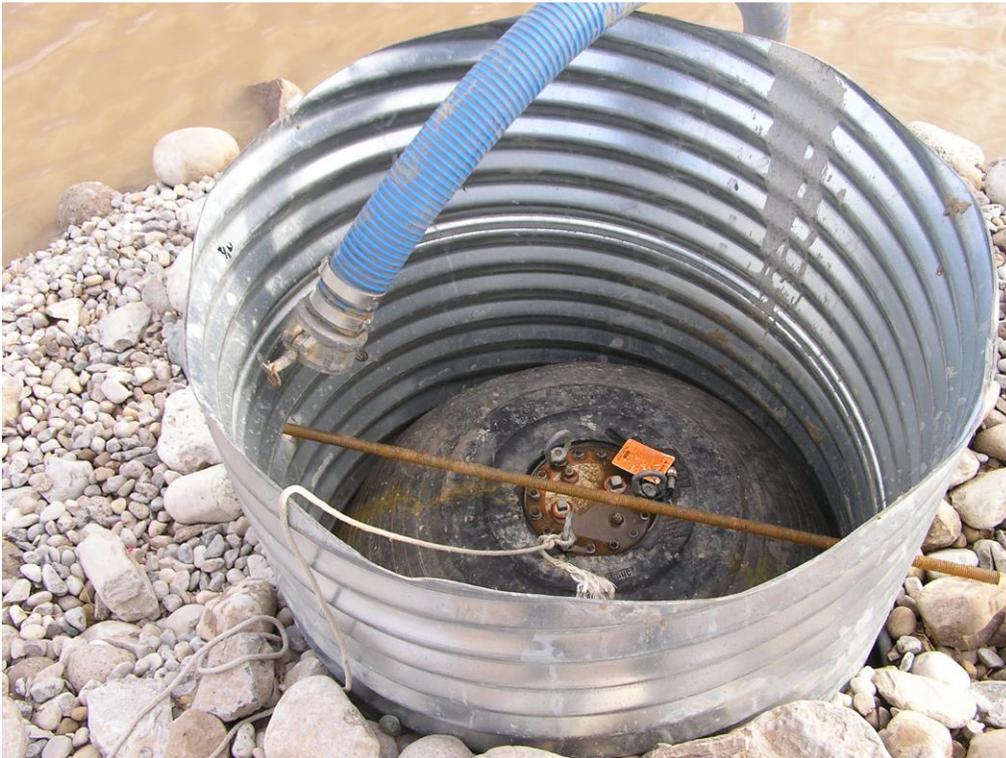
Basin #2 was plugged during the November 7, 2014 site visit (*refer to Photographs #14 and #15*), and a mobile stormwater treatment/filtration system was on-site. According to on-site Pro-Act personnel, Mr. Tony Chulski, this mobile stormwater treatment system is intended to remove suspended solids/clarify stormwater prior to discharge, and consists of two (2) Geotubes®, the addition of WaterSolve¹ - an organic polymer/flocculant in a mixing tank, three (3) sand and gravel filters, and four (4) ½ micro-fiber filters in series, and was reportedly brought on-site on Friday, October 31, 2014. *Refer to Photographs #10 through #13.* The mobile stormwater treatment system discharged treated stormwater from the basin to a sediment decant/filter bag on native soils south of Basin #2 on the date of the inspection. *Refer to Photographs #16 and #17.* No sediment was observed to be suspended within or picked up upon the discharge of treated stormwater from geotextile bags at the time of this site visit. *Refer to Photographs #18 and #19.* The system is reportedly operating 24 hours per day with remote telemetry to Mr. Chulski, the day shift system operator, if system upsets occur and require his off-hours visit to the system to maintain and/or put the system back on-line. Finally, the use of such polymers to enhance the removal of suspended solids from GTTC/VGT stormwater is likely the source of foam recently

Photograph #14: Basin #2, south-western portion of the GTTC/VGT property showing plug within basin outflow control structure. Taken by C. Grobbel, Grobbel Environmental & Planning, November 7, 2014.

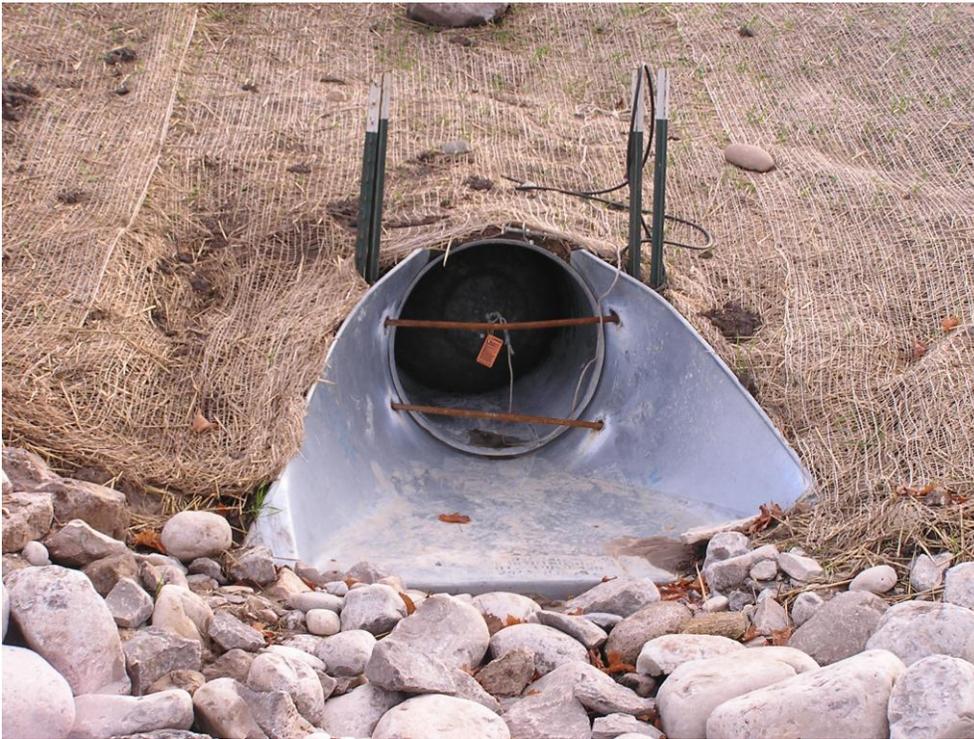
Photograph #15: Basin #2, south-western portion of the GTTC/VGT property showing plug within basin outlet structure. Taken by C. Grobbel, Grobbel Environmental & Planning, November 7, 2014.

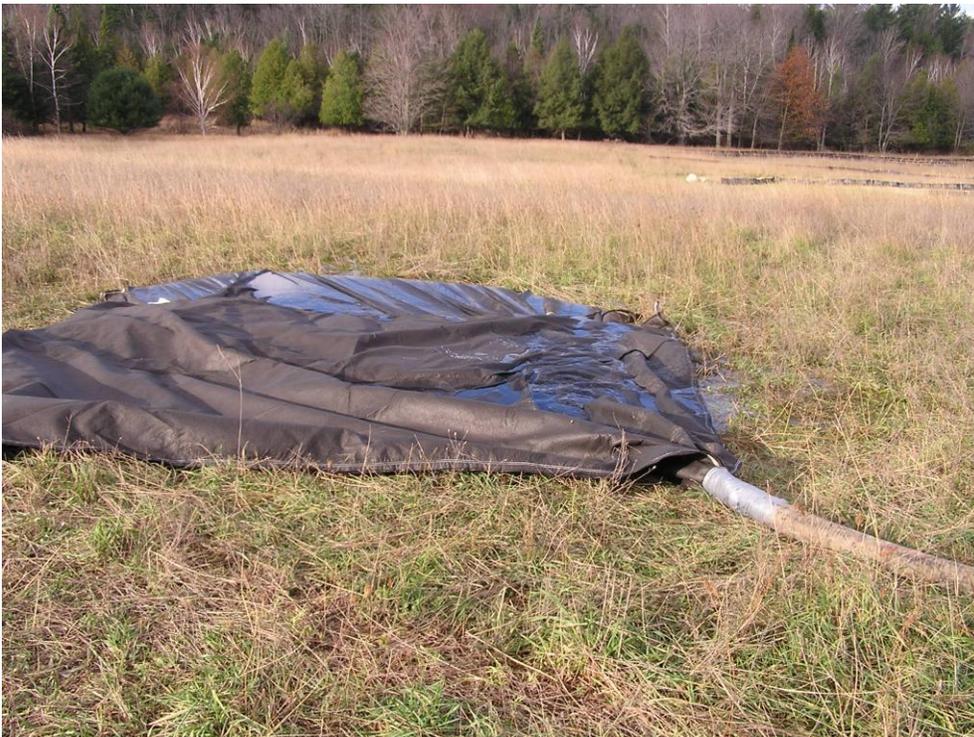
Photograph #16: Geotextile sediment decant/filter bag from mobile stormwater treatment/filtration unit from Basin #2, south-western portion of the GTTC/VGT property looking northwesterly. Taken by C. Grobbel, Grobbel Environmental & Planning, November 7, 2014.

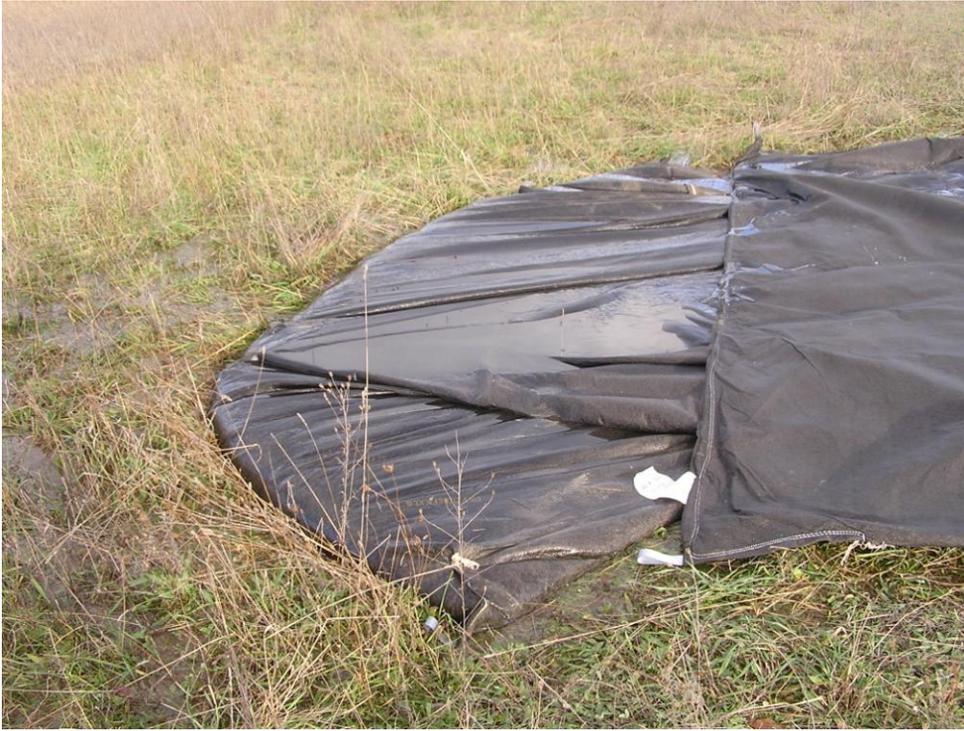
Photograph #17: Clear treated stormwater discharge from geotextile sediment decant/filter bag from mobile stormwater treatment/filtration unit at Basin #2, south-western portion of the GTTC/VGT property looking northerly. Taken by C. Grobbel, Grobbel Environmental & Planning, November 7, 2014.

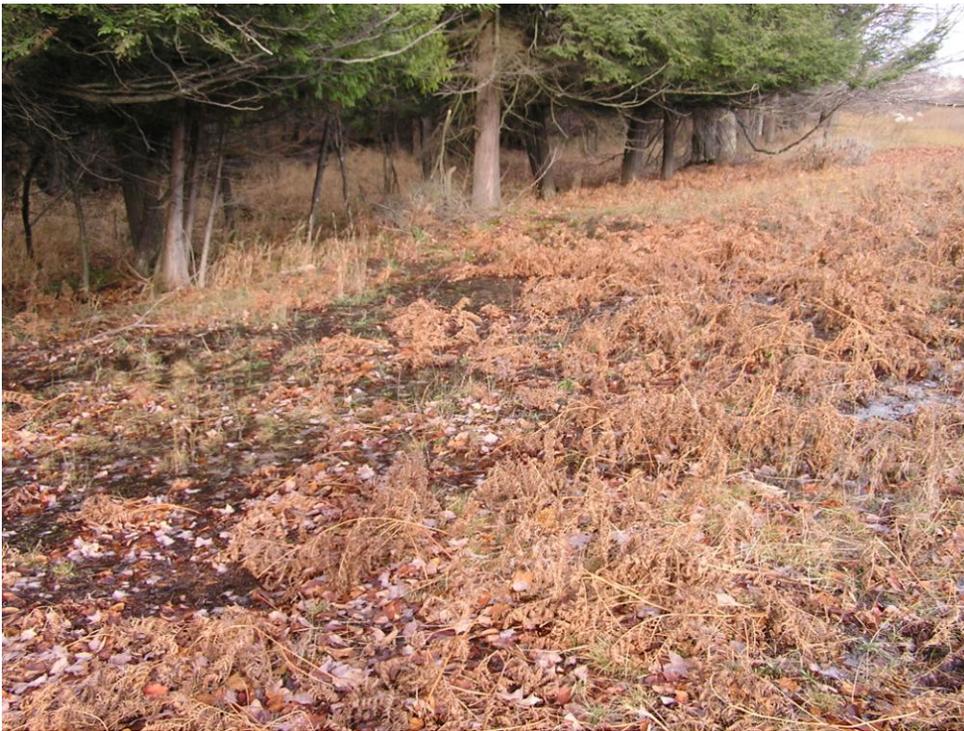
Photograph #18: Sheet flow of treated stormwater from geotextile bag from Basin #2 at riparian wetlands at south-western portion of the GTTC/VGT property, looking northerly and showing clear runoff. Taken by C. Grobbel, Grobbel Environmental & Planning, November 7, 2014.

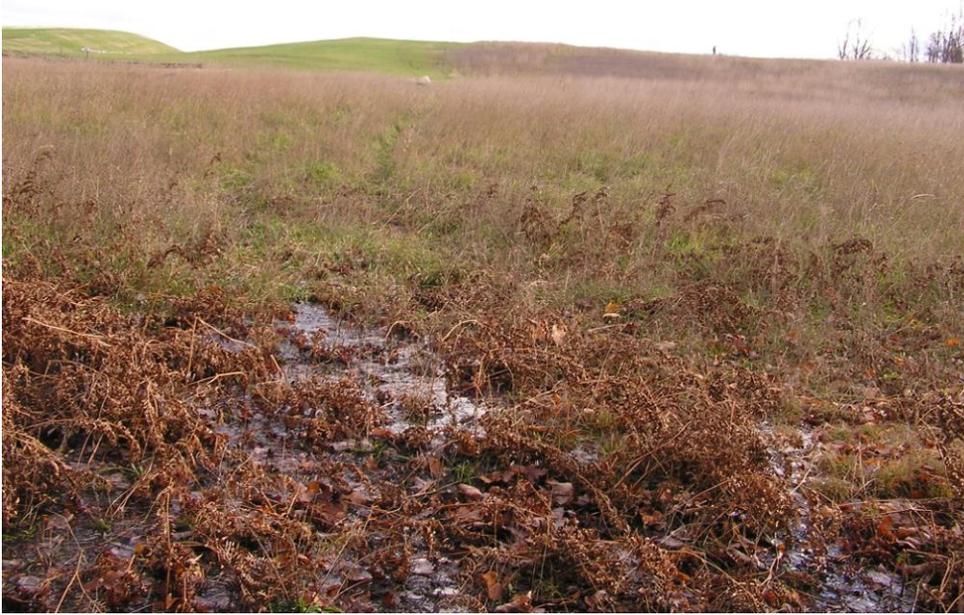
Photograph #19: Sheet flow of treated stormwater from geotextile bag from Basin #2 to riparian wetlands at south-western portion of the GTTC/VGT property, looking easterly and showing clear runoff. Taken by C. Grobbel, Grobbel Environmental & Planning, November 7, 2014.

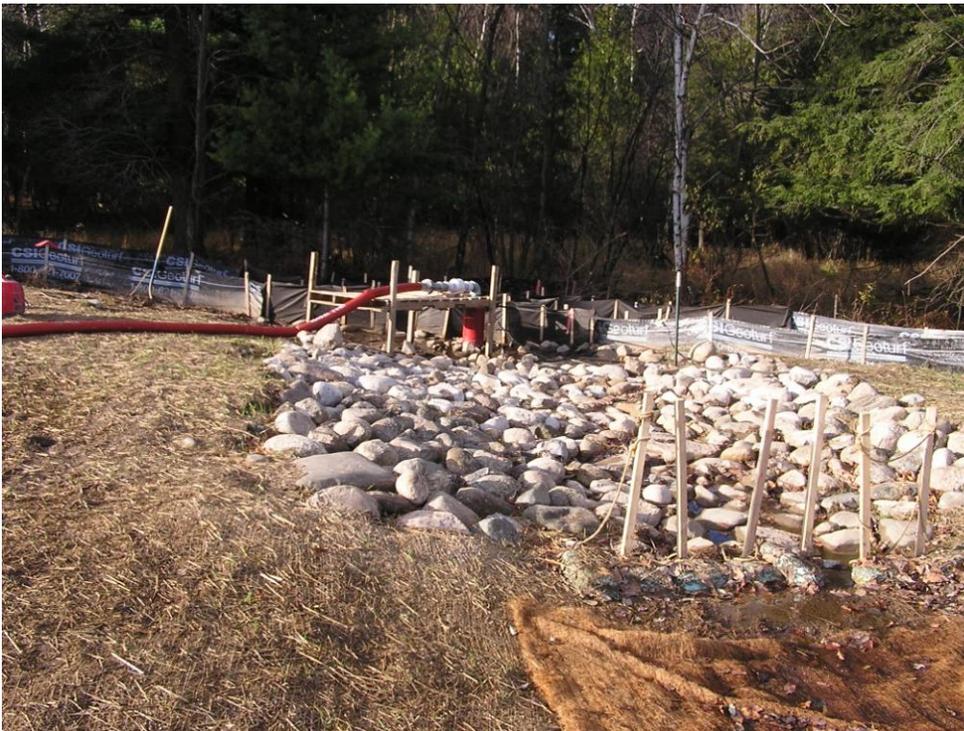
Of note was the presence of a pump/filtration system at the terminus of the grassed waterway from Basin #2 to return stormwater discharged from Basin #2 back to the same the basin, and suggesting the likelihood of sediment laden stormwater to Acme Creek/riparian wetlands sometime prior to this site inspection. No clay sediment was observed within wetlands or entering Acme Creek at and downstream/downslope this location on November 7, 2014.

Photograph #20: Basin #2 rip rap discharge structure/grassed waterway terminus with pump/filter system back to Basin #2, PAM blocks and numerous layers of silt fence, southwestern portion of the GTTC/VGT property looking westerly. Taken by C. Grobbel, Grobbel Environmental & Planning, November 7, 2014.

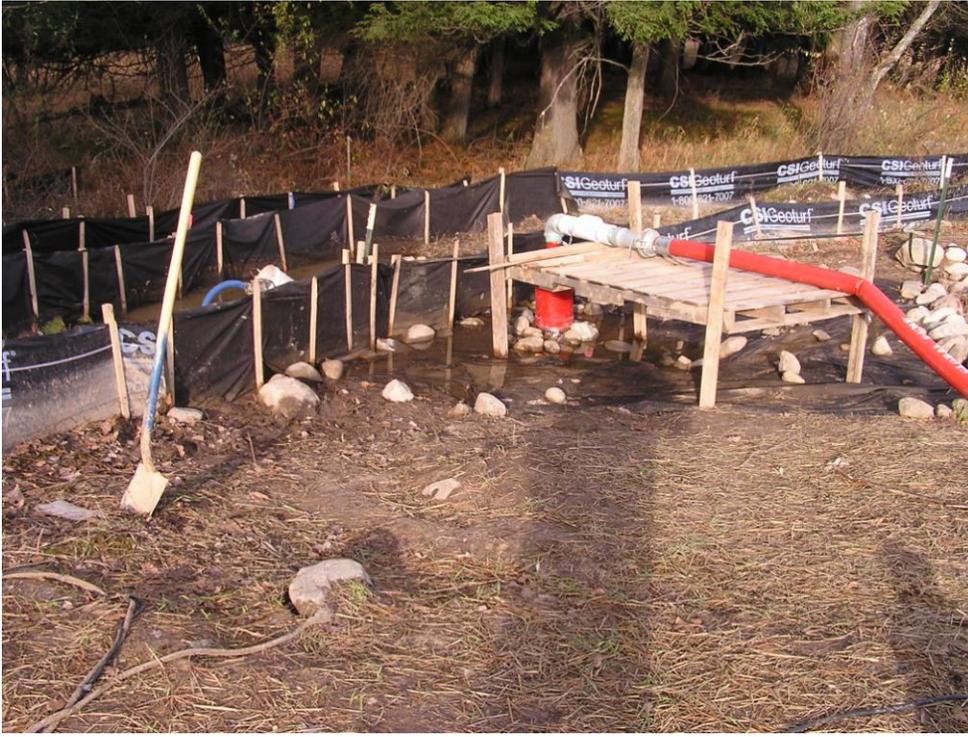
Photograph #21: Basin #2 rip rap discharge structure/grassed waterway terminus with pump/filter system back to Basin #2 and numerous layers of silt fence, south-western portion of the GTTC/VGT property looking northwesterly. Taken by C. Grobbel, Grobbel Environmental & Planning, November 7, 2014.

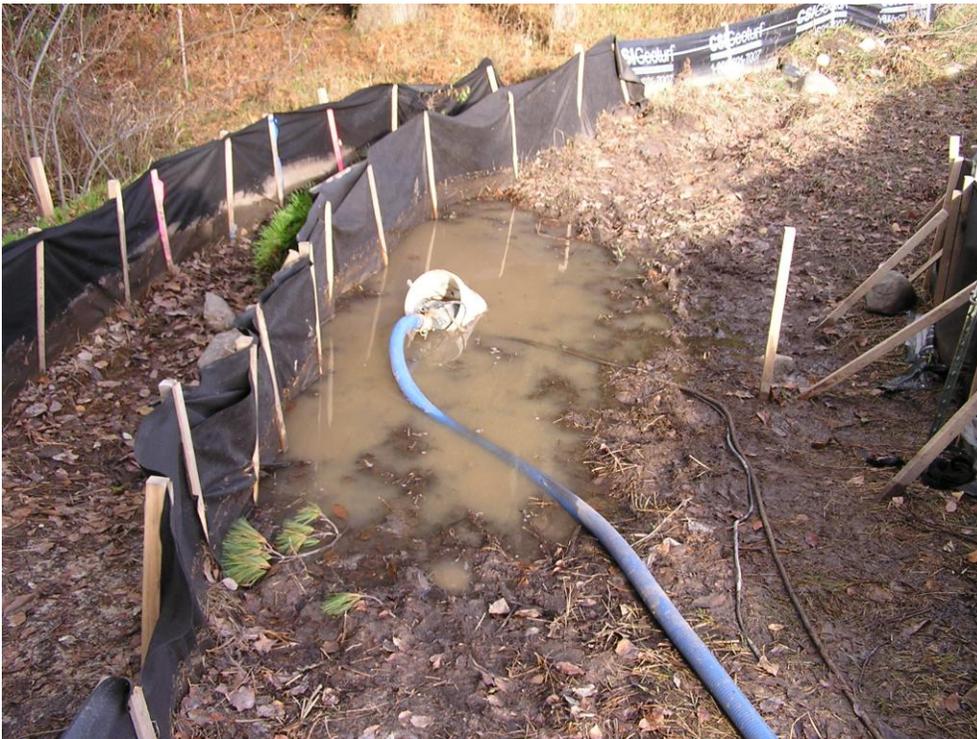
Photograph #22: Basin #2 rip rap discharge structure/grassed waterway terminus with pump system back to Basin #2 and numerous layers of silt fence, south-western portion of the GTTC/VGT property looking northwesterly. Taken by C. Grobbel, Grobbel Environmental & Planning, November 7, 2014.

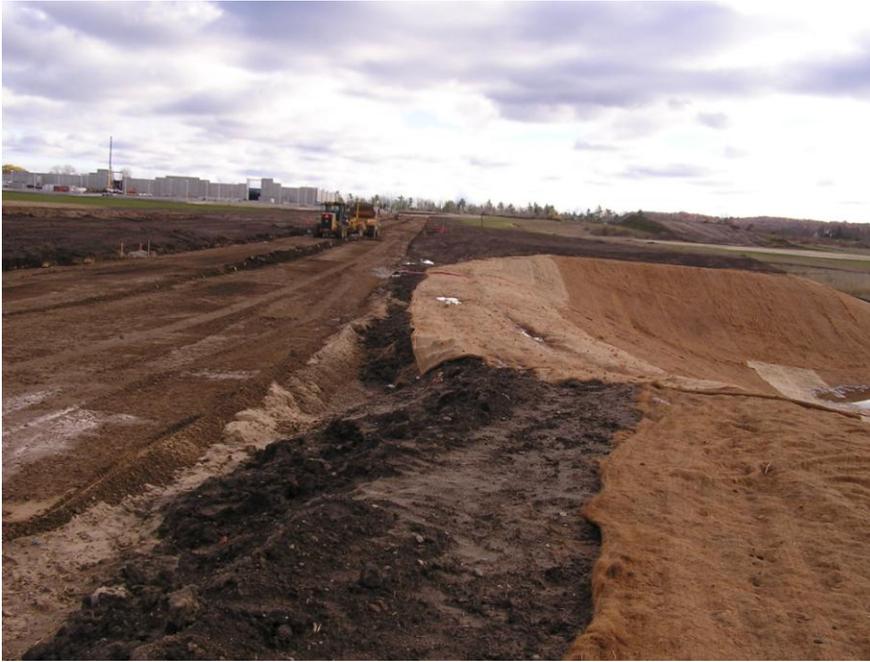
- 3) **Swale at South-southwest Portion of the GTTC/VGT Site** – As shown in Photographs #23 through #28 below, top soil and erosion control matting has been properly placed within the swale at the south-southwest portion of the GTTC/VGT property. No sediment was observed on

Photograph #23: Topsoil and erosion control matting being placed at the swale in the south-southwestern portion of the GTTC/VGT property looking easterly. Taken by C. Grobbel, Grobbel Environmental & Planning, November 7, 2014.

November 7, 2014 beyond the silt fence/straw bale structure at this location, and no impact to downgradient wetlands or Acme Creek was observed. *It is recommended that the swale be effectively stabilized through vegetation as soon as possible at this location.*

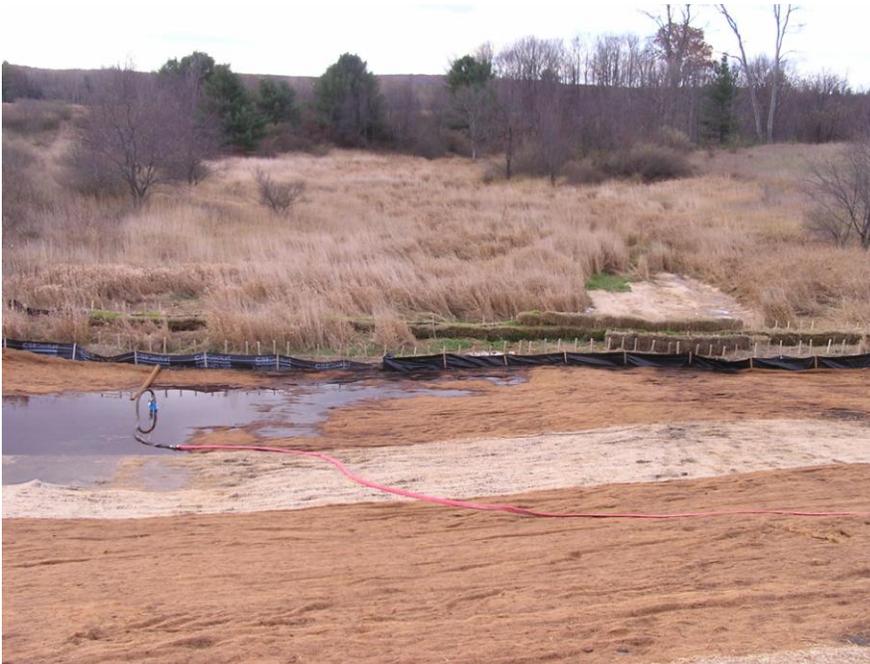
Photograph #24: Erosion control matting, silt fence/straw bales and trash pump to Basin #2 at the discharge point of swale in the south-southwestern portion of the GTTC/VGT property looking southerly. Taken by C. Grobbel, Grobbel Environmental & Planning, November 7, 2014.

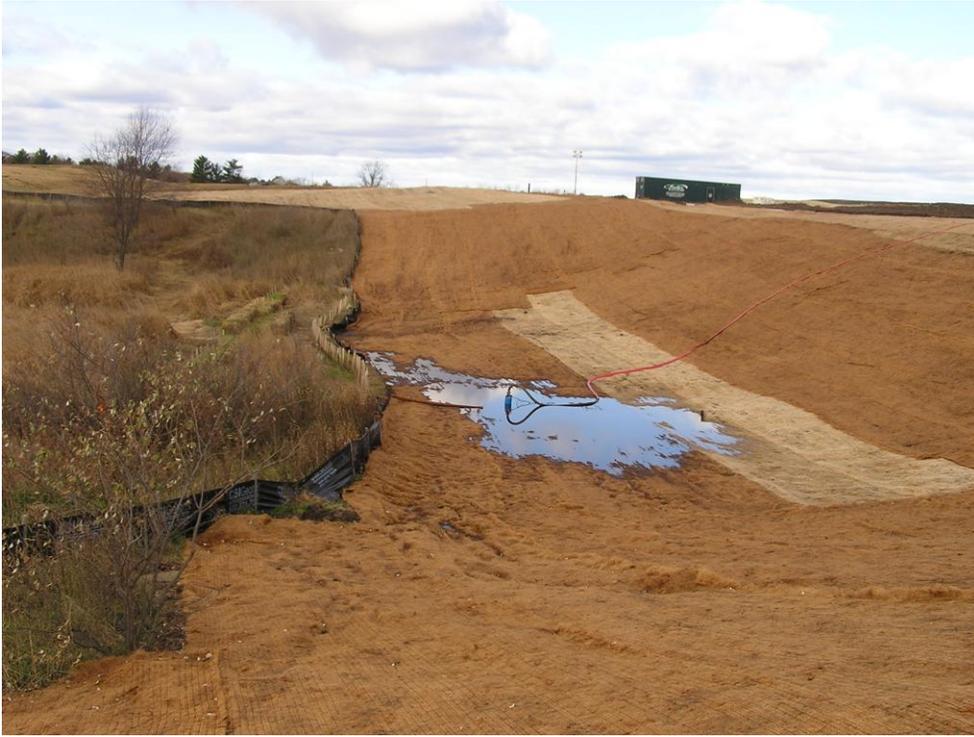
Photograph #25: Erosion control matting, silt fence/straw bales and trash pump to Basin #2 at the discharge point of swale in the south-southwestern portion of the GTTC/VGT property looking westerly. Taken by C. Grobbel, Grobbel Environmental & Planning, November 7, 2014.

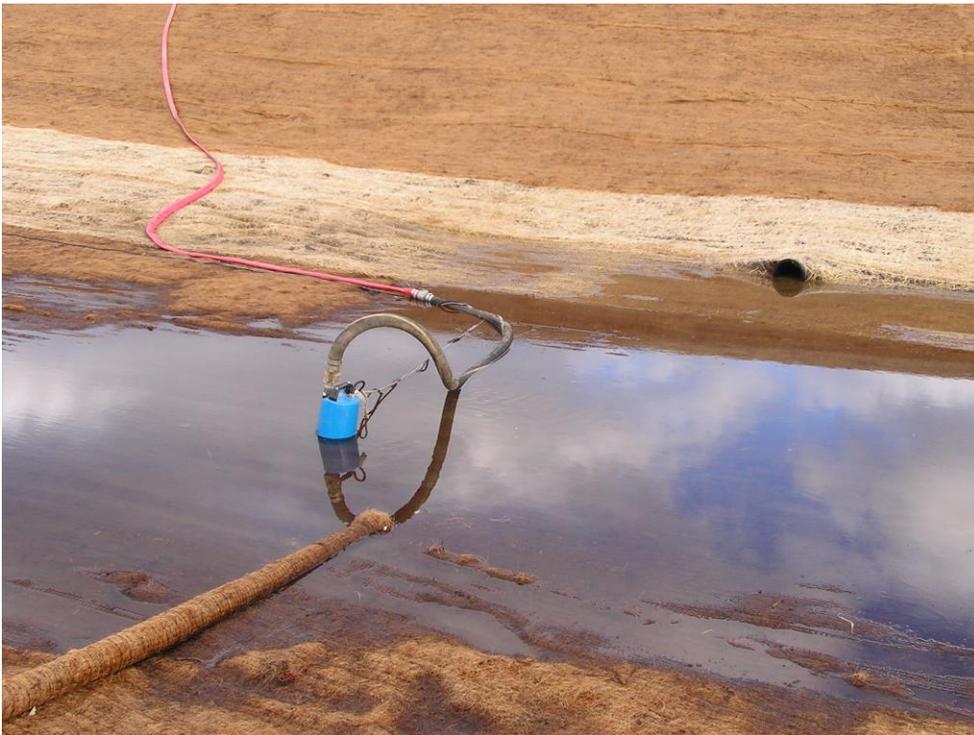
Photograph #26: Trash pump to Basin #2 at the discharge point of swale in the south-southwestern portion of the GTTC/VGT property looking northerly. Taken by C. Grobbel, Grobbel Environmental & Planning, November 7, 2014.

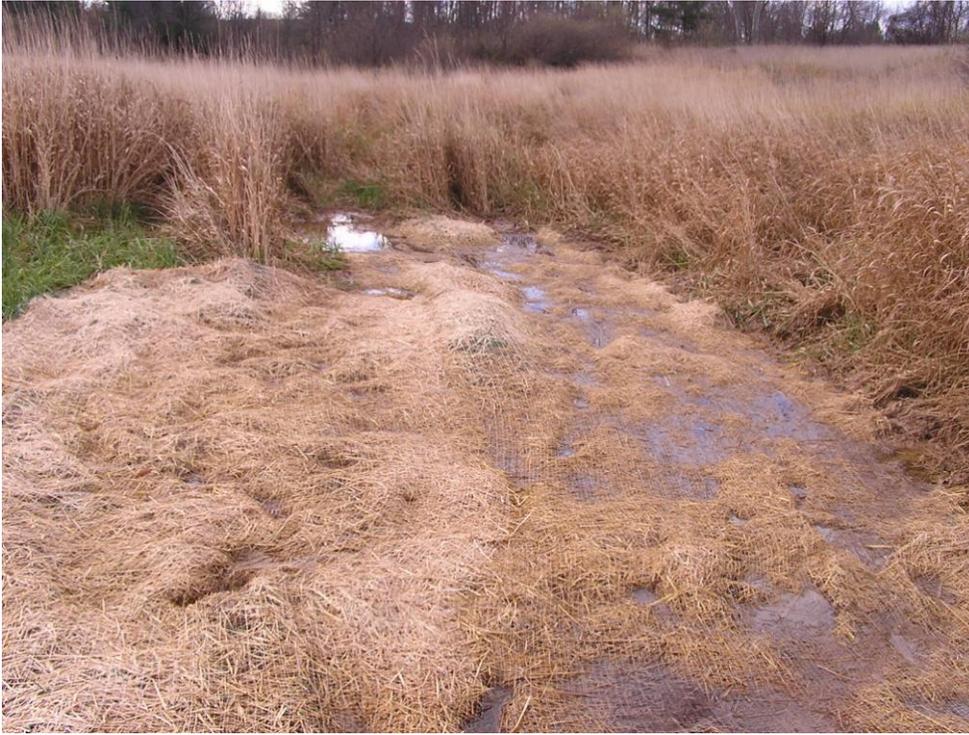
Photograph #27: Clear, sediment-free discharge from the swale in the south-southwestern portion of the GTTC/VGT property looking southerly. Taken by C. Grobbel, Grobbel Environmental & Planning, November 7, 2014.

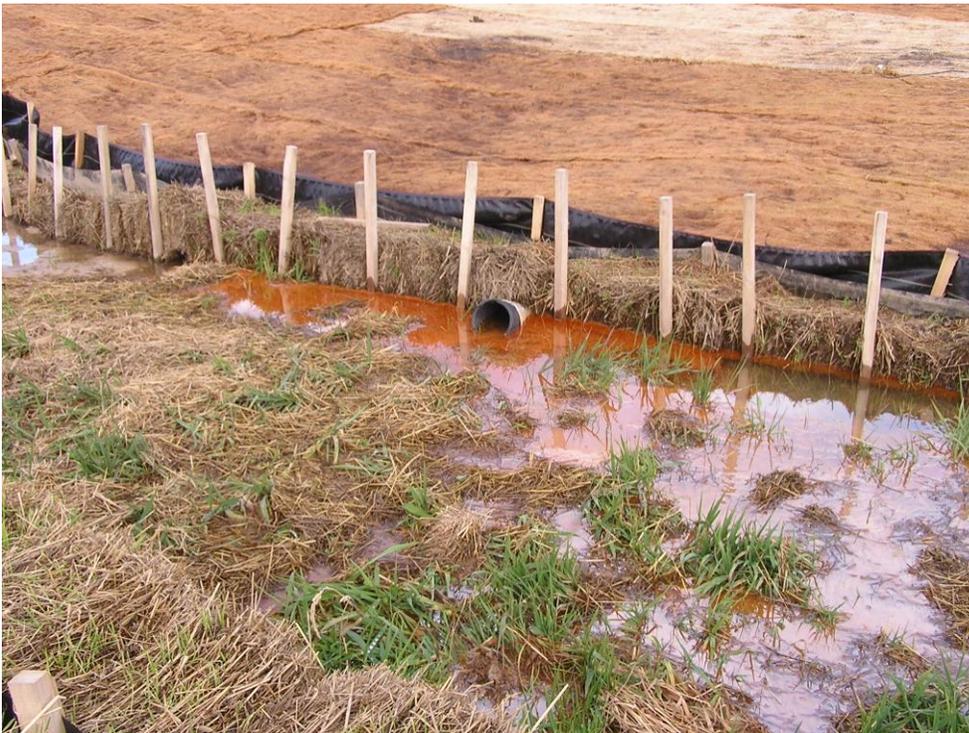
Photograph #28: Iron bacteria at tile discharge from the swale in the south-southwestern portion of the GTTC/VGT property looking northwesterly. Taken by C. Grobbel, Grobbel Environmental & Planning, November 7, 2014.
