Grobbel Environmental & Planning Associates

November 10, 2014

RE: Review of Stormwater Management and Soil Erosion Control Measures, GTTC/VGT, M-72 Highway, Acme Township, Grand Traverse County, Michigan from November 7, 2014 Site Visit.

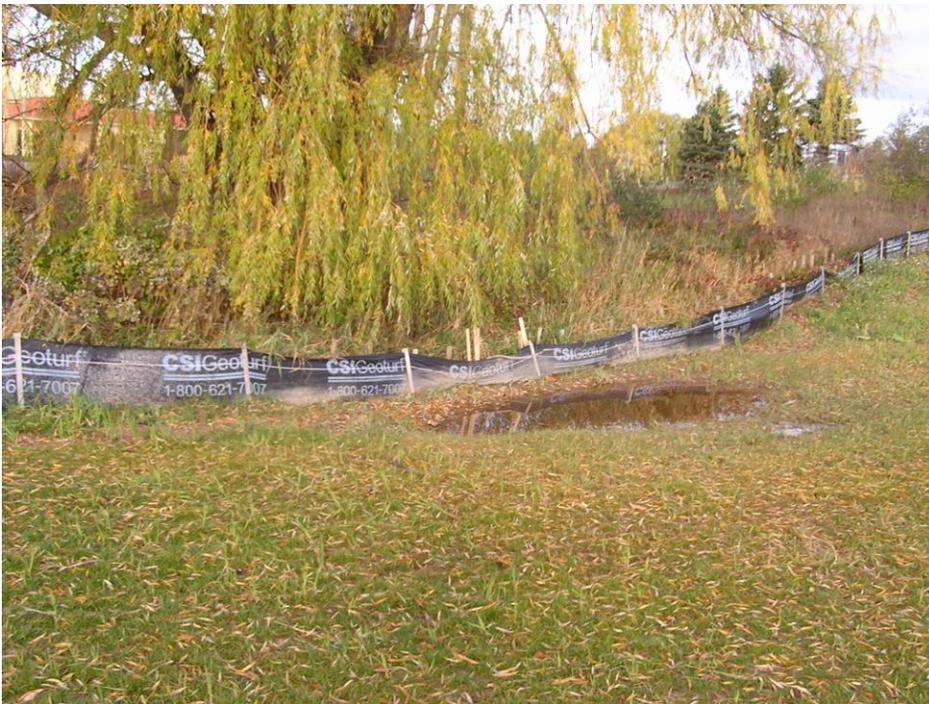
- 4) **Northwestern Corner of the GTTC/VGT Site** – As shown in Photographs #29 and #30 from November 7, 2014. Stormwater control BMPs have been placed within the swale along the dinner theater property and stormwater from the GTTC/VGT is and has been discharged to the existing dinner theater stormwater treatment system. It is recommended that records for the Acme Township and Grand Traverse County-approved stormwater system at the dinner theater be evaluated to assess this system’s ability to receive additional flow and/or suspended solids from the GTTC/VGT site. It is typically unlawful for a development to increase stormwater flows to adjoining parcels/properties.

Photograph #29: Stormwater collected within a swale upgradient of the stormwater retention pond at the adjacent dinner theater within the northwestern portion of the GTTC/VGT property looking northwesterly. Taken by C. Grobbel, Grobbel Environmental & Planning, November 7, 2014.

Additionally, the ultimate disposition of the stormwater retention basin at the dinner theater, ostensibly Acme Creek, should be determined and evaluated for potential impacts to the Creek from stormwater discharged from the northwest portion of the GTTC/VGT site. No sediment was observed to be eroding from or transported off the GTTC/VGT site, into wetlands or into Acme Creek on the time of this site visit.

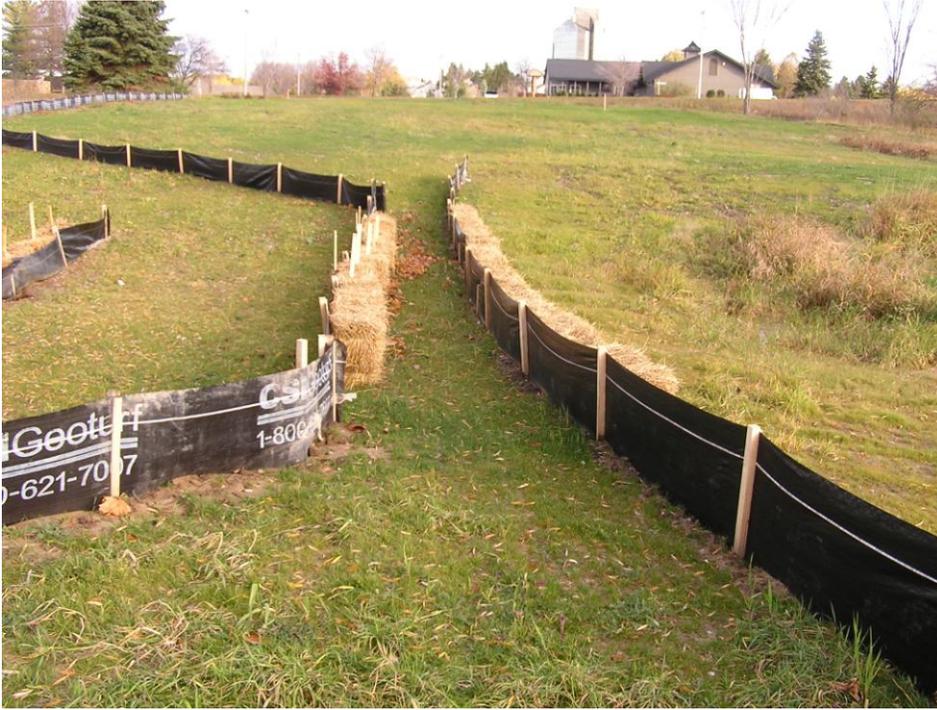
Photograph #30: Erosion control BMPs in the northwest corner of the GTTC/VGT property upgradient and adjacent to the dinner theater, looking north. Taken by C. Grobbel, Grobbel Environmental & Planning, November 7, 2014.
