July 23, 2015

Subject: Site review of Grand Traverse Town Center Plantings at Basin #1 and Basin #2

**Grand Traverse Town Center Plantings
Representative Photographs
Acme Township, Grand Traverse County**

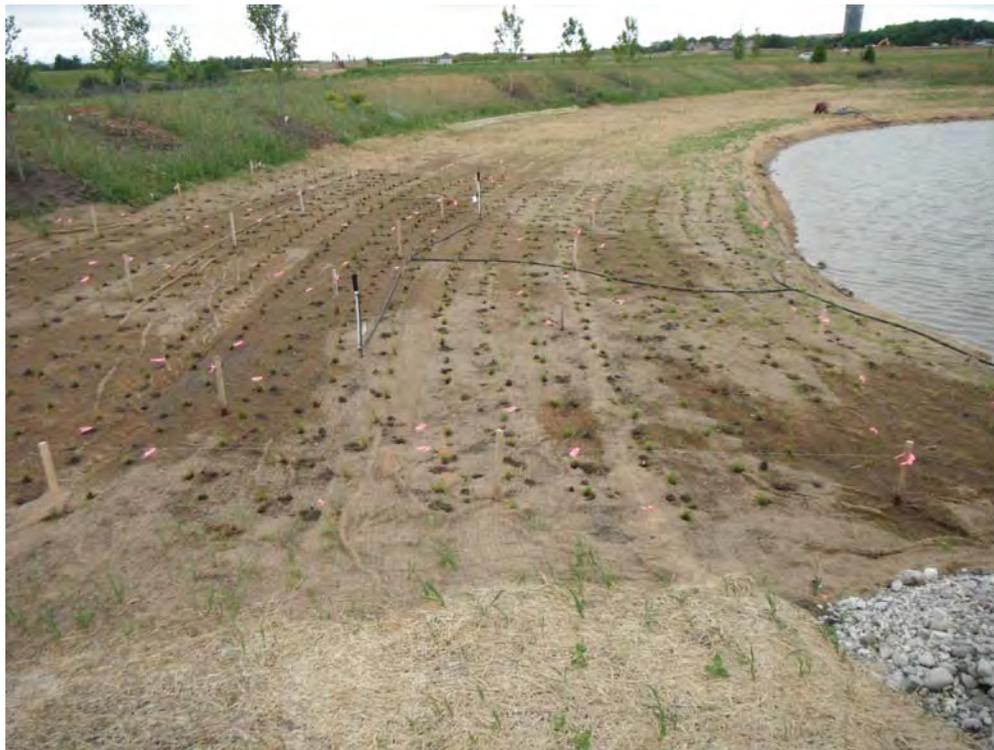
Basin #1 is designed to be seeded above the 654 contour elevation. Most of the area was proposed to be seeded with a small area reserved for plug installation. The review of this basin revealed that there were no plants emerging from the seed mix specified in the planting plan. The identifiable plants included lamb's quarters (*Chenopodium album*), crabgrass (*Digitaria sanguinalis*), bindweed (*Convolvulus arvensis*), and smartweed (*Polygonum pensylvanicum*). These are opportunistic "weedy" species that are typically found in new planted areas without a sufficient temporary cover crop. In area planted with plugs, lake sedge (*Carex lacustris*), rice cutgrass (*Leersia oryzoides*), and arrowhead (*Sagittaria latifolia*) were three of the listed plug species in the planting plan identified. The installed plugs appeared to be doing well and there were no signs of stress or herbivory (Photo 1). The plugs were being irrigated by sprinklers, but it is unknown the frequency of irrigation on these plants. The existing water level occurred at an elevation approximately two feet below the plug elevation (Photo 2) which could be a hydrology issue for these plants once the sprinklers are removed from the area. The basin design shows four habitat structures (whole trees) to be placed within the basin, these habitat structures are not present. Placement of the habitat structures after planting may incur damage to the grades or plantings.

Photograph No. 1. Basin #1 Plug installation area.

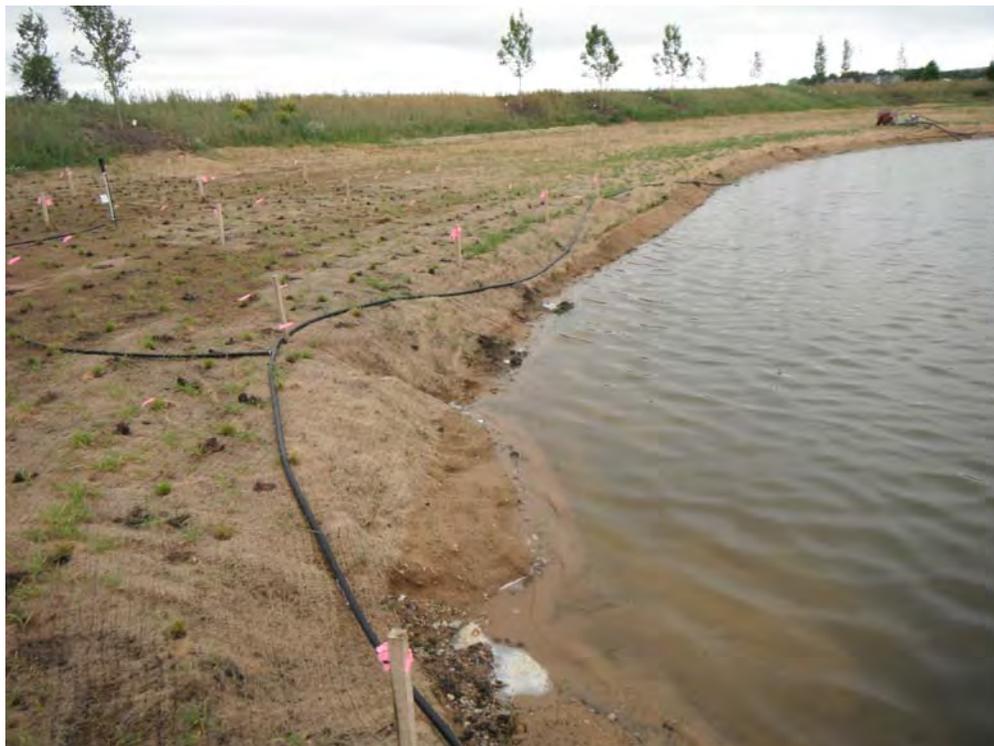
Photograph No. 2. Water level in Basin #1 below planting elevation.

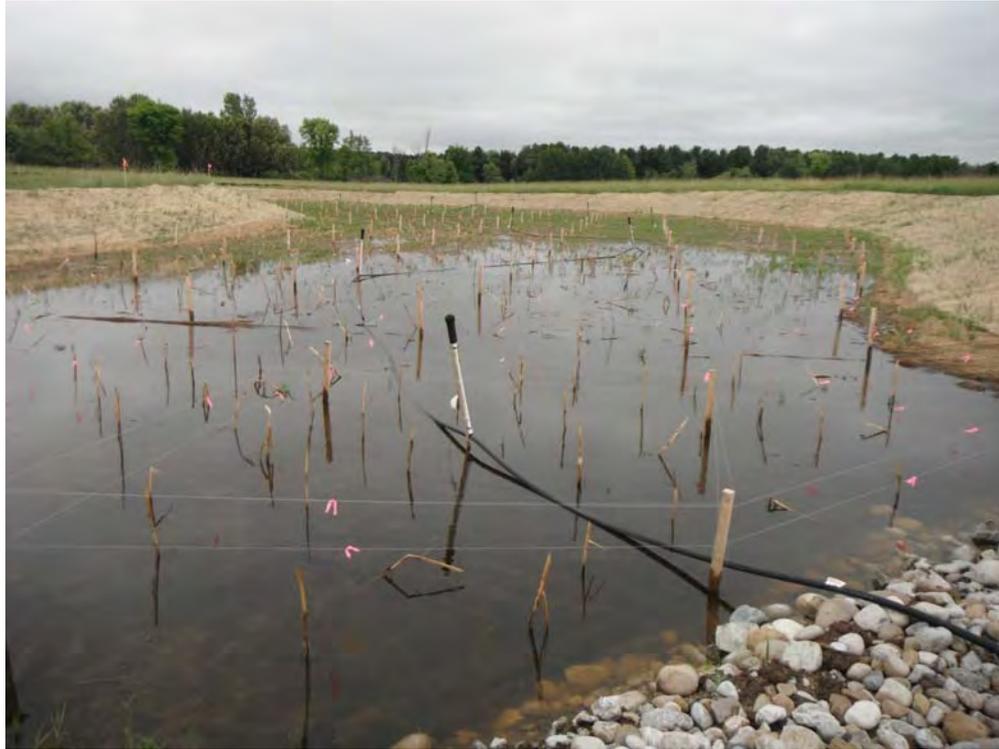
Photograph No. 3. Basin #1A

The overflow from Basin #1 flows into Basin #1A. Basin #1A appears to have suitable hydrology within the basin to support hydrophytic vegetation (Photo 3). The hydrology varies from saturated soils to three inches of inundation. This entire basin was planted with plugs. All of the plants observed were listed in the planting list. The three-square bulrush (*Scirpus pungens*) and river

bulrush (*Scirpus fluviatilis*) did not survive through the initial planting phase. The cattail (*Typha latifolia*) plants appeared to have an approximately 50% survival rate. The lake sedge and rice cutgrass appears to be doing well with no mortality observed. Water plantain (*Alisma plantago-aquatica*) also appears to be doing very well.

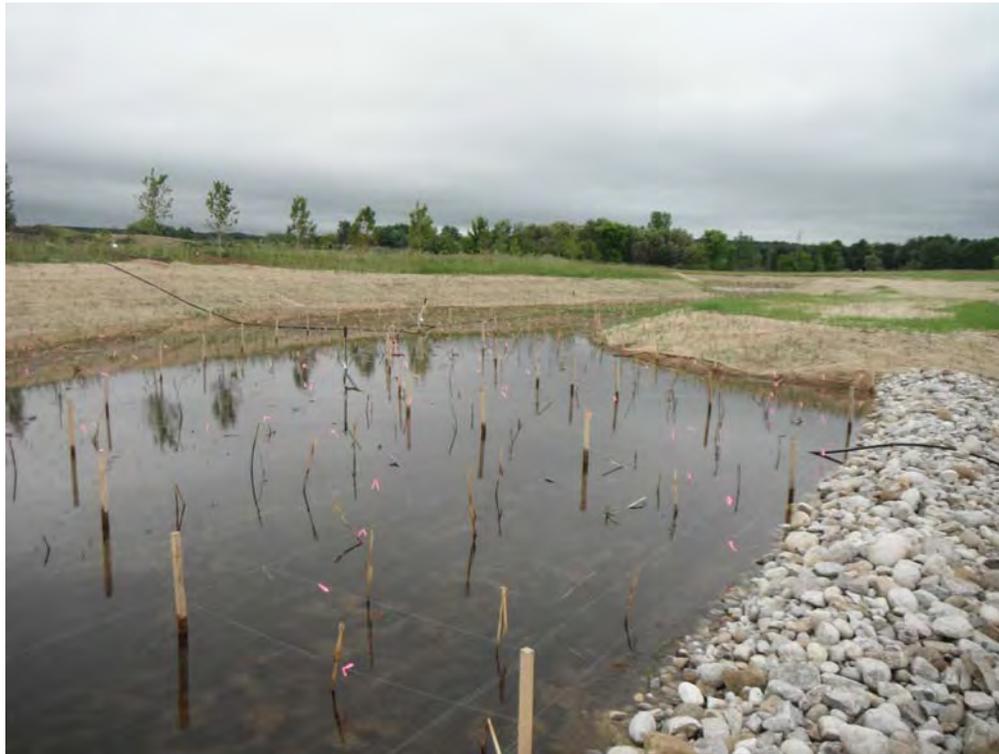
Photograph No. 4. Basin #1B

Overflow from Basin #1A flows into Basin #1B. Basin #1B also appears to have suitable hydrology for supporting hydrophytic plants (Photo 4). A large majority of this basin was inundated with approximately six inches of water. All of the plants observed were listed in planting plan. The entire area in this basin appears to have been planted with plugs. Plants observed with 100% mortality included the three-square bulrush and river bulrush. Cattail appeared to have a 50% mortality. Rice cutgrass and lake sedge appeared to be doing well and did not have any mortality (Photo 5). No other species were observed in this basin.

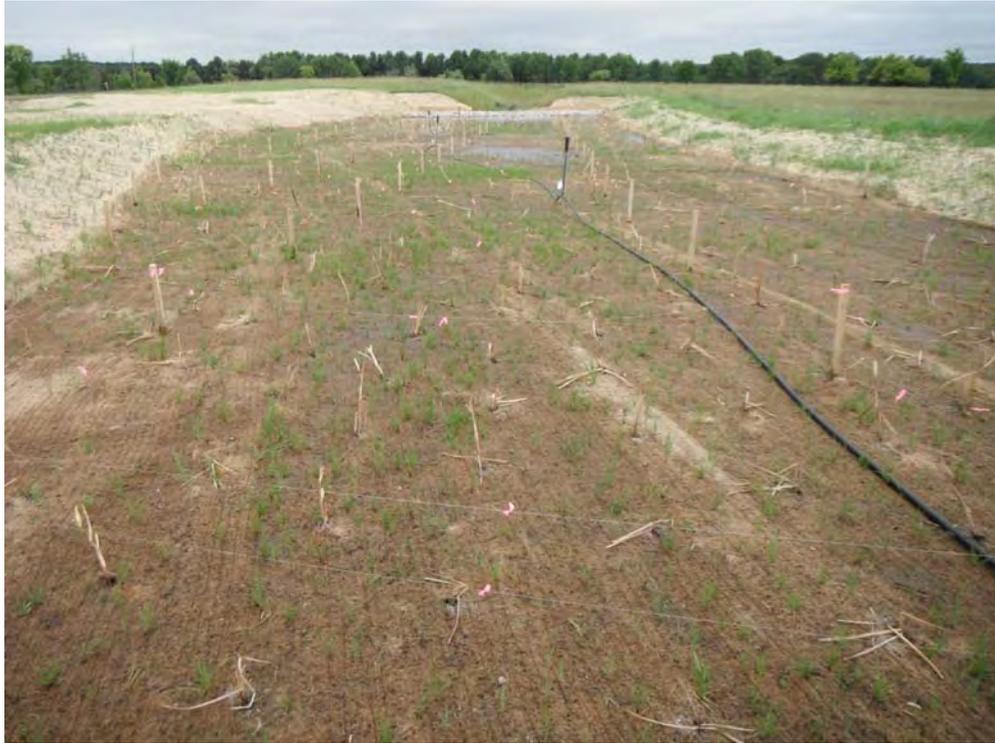
Photograph No. 5. Basin #1B facing east.

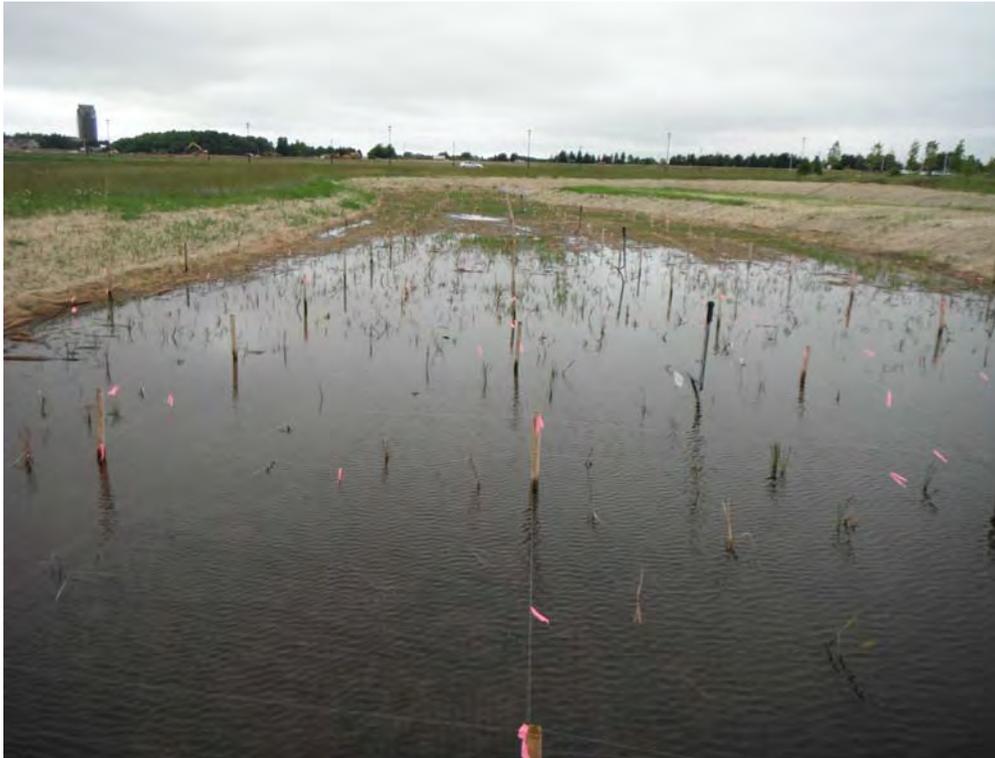
Water overflows a low head rock berm and flows into Basin #1C. Basin #1C has saturated soil at the location of the low head berm by Basin #1B and gradually inundates with water to a depth of 6-12 inches at the low head berm leading into the discharge swale (Photo 6). In this basin arrowhead, cattails, bur reed (*Sparganium eurycarpum*), water plantain, rice cutgrass, and lake sedge were observed. Approximately 50% of the cattails observed were dead, 90% of the bur reed were dead, and the river bulrush were all dead. The rice cutgrass, lake sedge, arrowhead, and water plantain did not appear to have any mortality. It appeared that this basin had suitable hydrology to support hydrophytic vegetation.

Photograph No. 6. Basin #1C facing north.

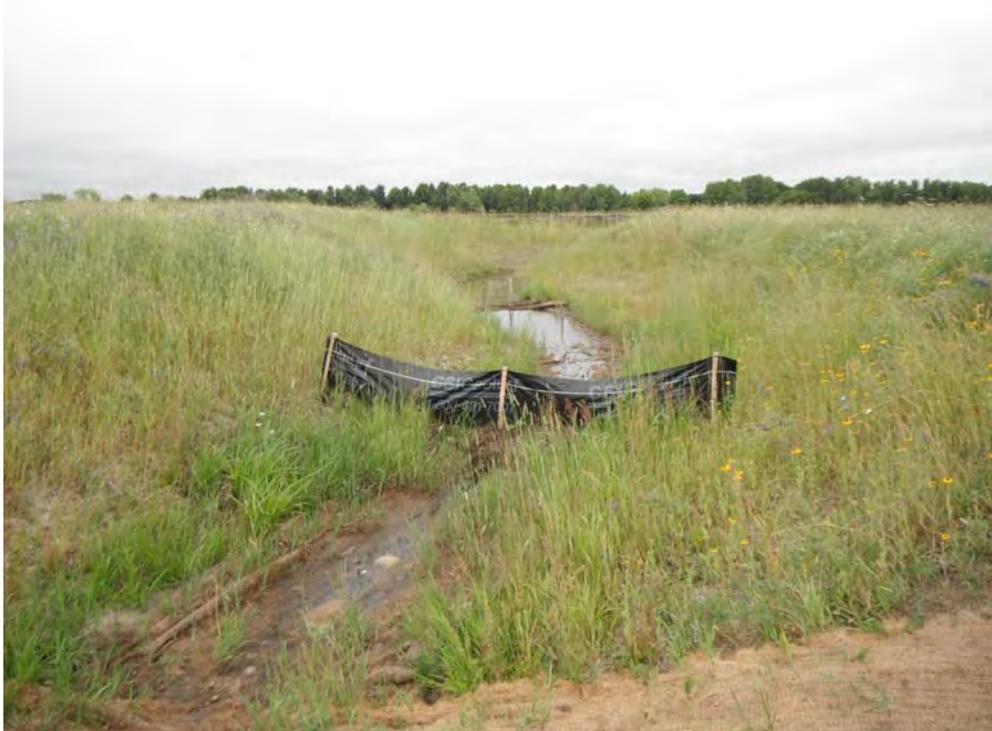
Photograph No. 7. Basin #1 Swale

The water overflows a low head berm in Basin #1C and flows into swale that ultimately discharges to a natural wetland area. The upper part of the swale was inundated and gradually transitioned into saturated soils (Photos 7 and 8). The plants observed in the swale included rye (*Lolium perenne*), redtop grass (*Agrostis gigantea*), curly dock (*Rumex crispus*), timothy (*Phleum pratense*), water plantain, sedge species (*Carex spp.*), rough-leaved goldenrod (*Solidago rugosa*), and big bluestem (*Andropogon gerardii*). Of the plants included on the planting list for the swale, sedges, big bluestem, and water plantain were listed. The other plants are volunteer species. This swale appeared to be effective in conveying water through the channel to discharge into the natural wetland. No sedimentation was observed being discharged into the natural wetland.

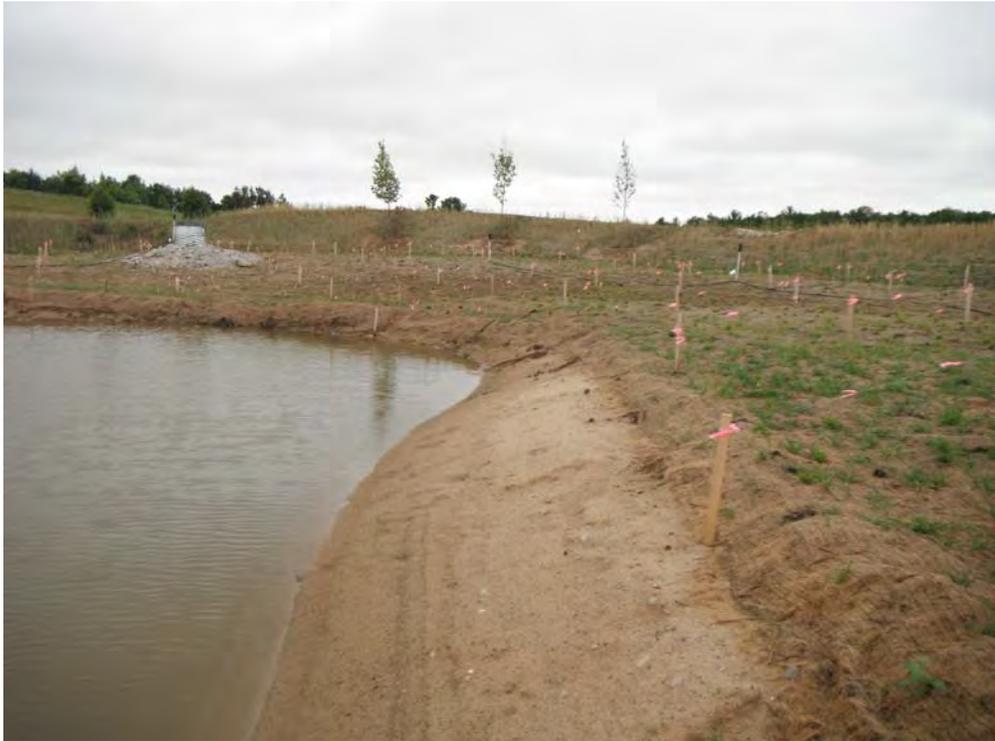
This basin is designed for an emergent wetland shelf of planted plugs from the 645 contour elevation up to the 650 contour elevation. The planted plugs and seeded area appear to be planted from the 648 contour elevation upwards to the 650 contour elevation, however this is an approximate observation and not verified with any survey equipment. The water level in the basin at the time of the site investigation appeared to be at the culvert invert elevation of 644 (four feet below the planted area) (Photo 9). The area had received 0.40 inches precipitation on the day that the site investigation had been conducted. Currently, the plug area is being irrigated with sprinklers, however if the water level remains at the current elevation, the plants will not have sufficient hydrology when the sprinkler system is removed. In the seeded areas (Photo 10), plants observed included lamb's quarters, crabgrass, field bindweed, yellow rocket (*Barbarea vulgaris*), white clover (*Trifolium repens*), smartweed, and common thistle (*Cirsium arvense*). None of these plants were in the seed mix, however if the area was seeded this year, it is not surprising that there are no seedlings appearing yet. Seven arrowhead plants and one lake sedge were observed in the plug area (Photo 11). The river bulrush and three-square bulrush were dead stalks (Photo 12). The ground appears to be compacted where the plugs were planted which makes it difficult for young seedlings to take root. Investigation of the soil in the plug area revealed the absence of organic soil.

Photograph No. 9. Basin #2. Water level below planting elevation.

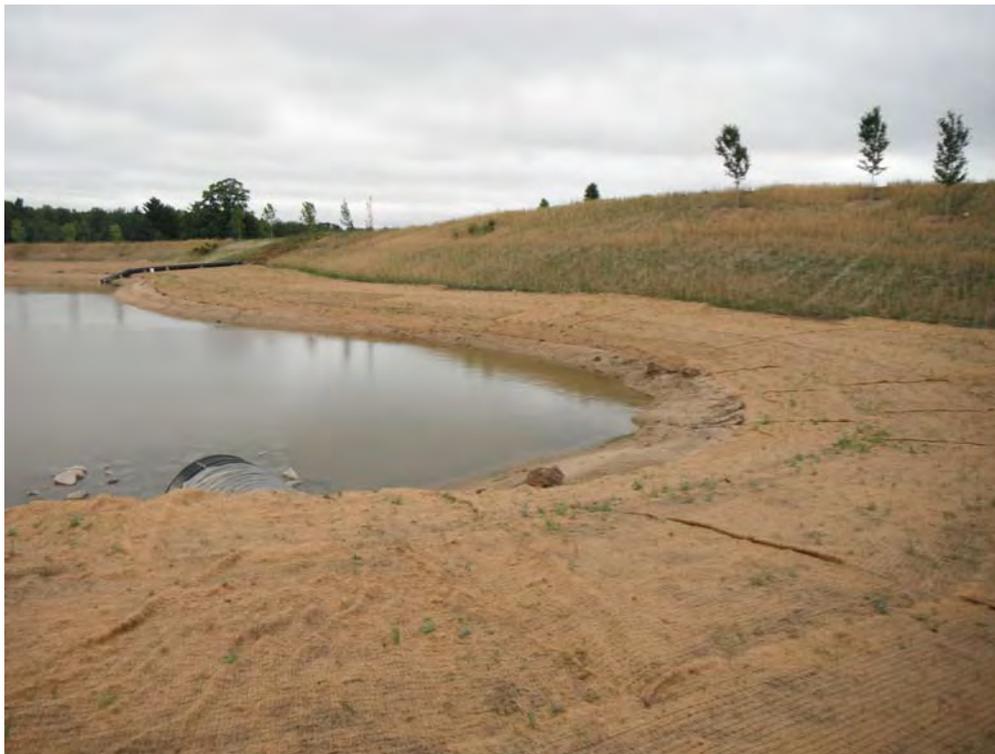
Photograph No. 10. Basin #2. Area that was seeded.

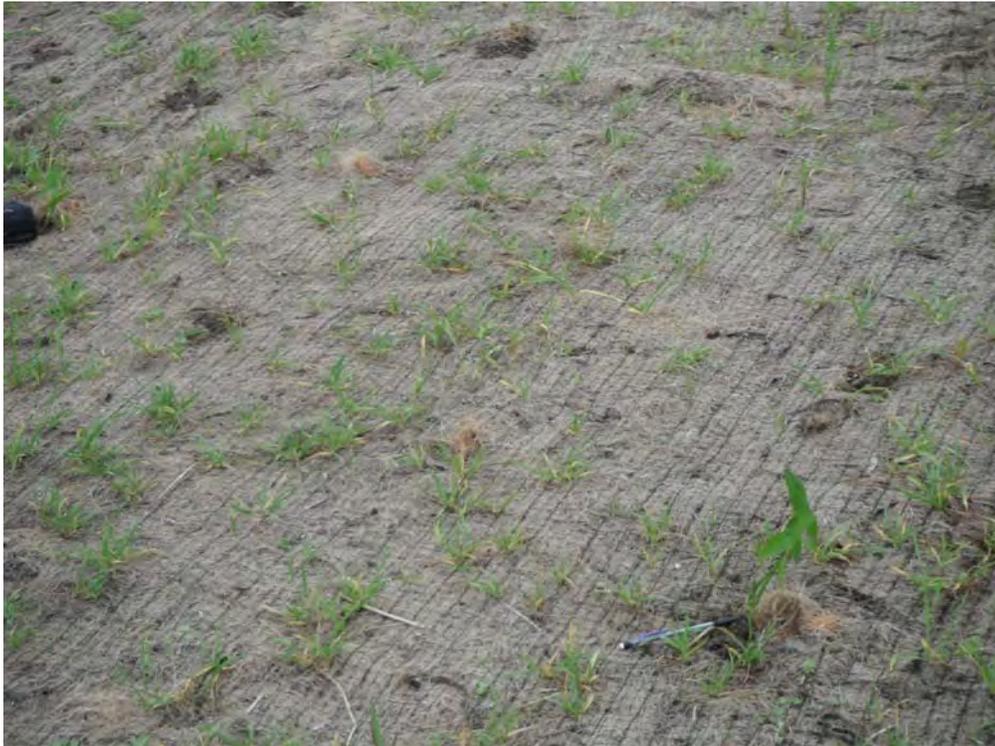
Photograph No. 11. Basin #2. Scattered arrowhead plant plugs.

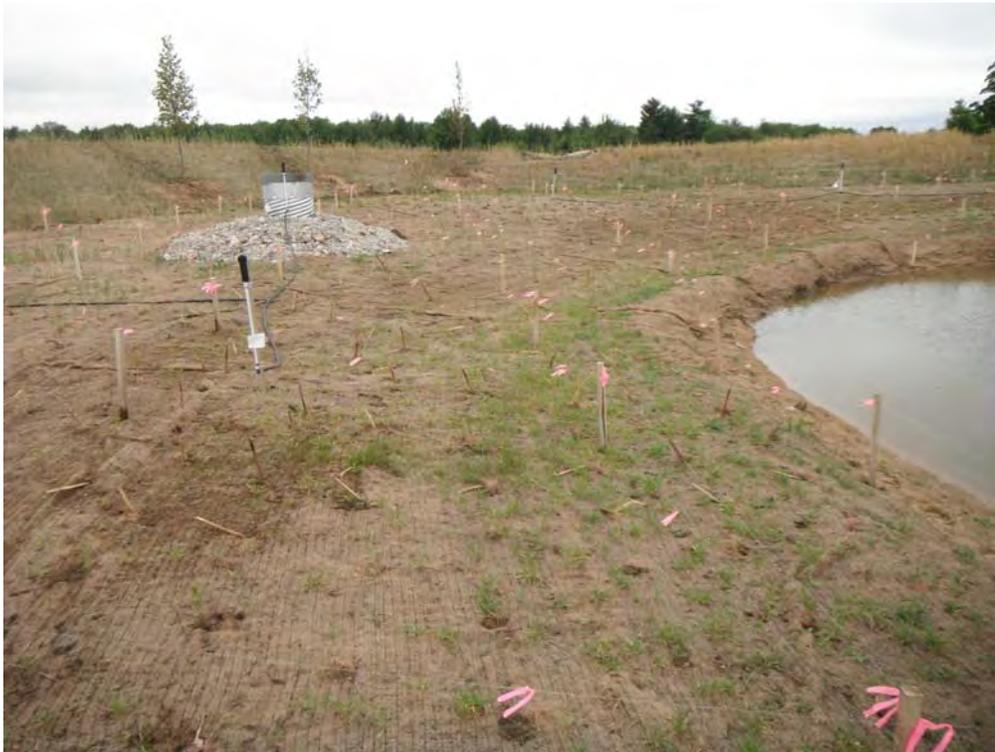
Photograph No. 12. Basin #2. Dead River Bulrush plugs.

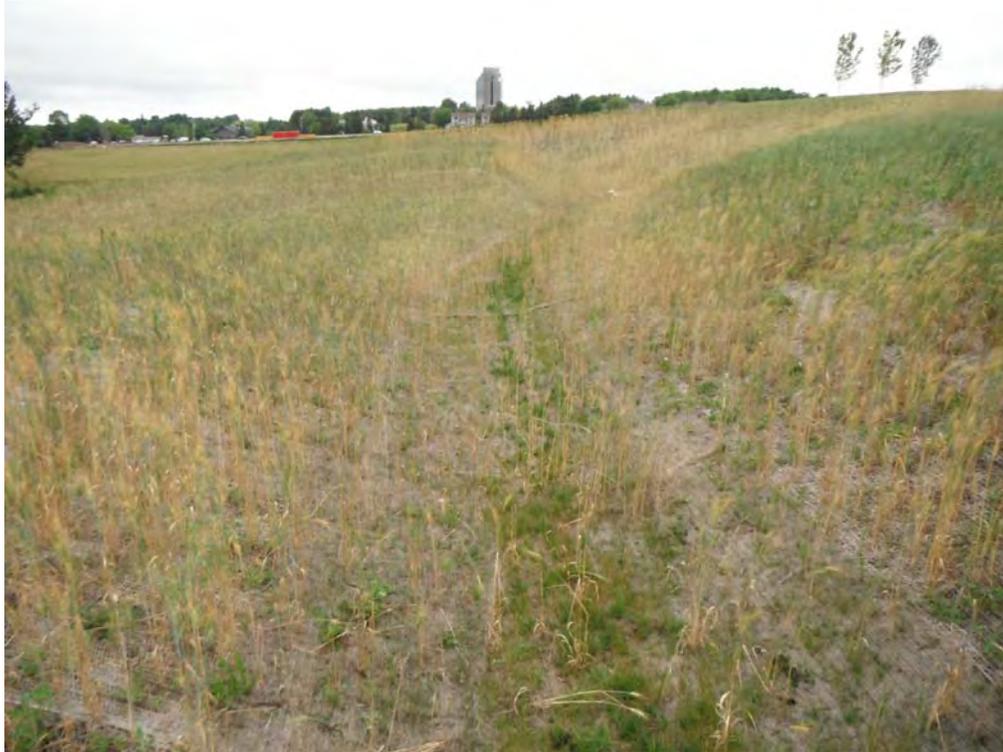
The overflow from Basin 2 appears to occur at the 654 contour elevation. The overflow leads into a swale which winds down to two created wetland depressions. Vegetation in the swale (Photo 13) includes foxtail (*Setaria glauca*), big bluestem, Queen Anne's lace (*Daucus carota*), red clover, curly dock, timothy, and seedbox (*Ludwigia alternifolia*). Big bluestem is the only plant observed that was in the planting list for the swale. The swale appears to be conveying water to the wetland depressions without any visible signs of erosion or sedimentation.

Photograph No. 13. Basin #2. Swale flowing towards Basin #2A.

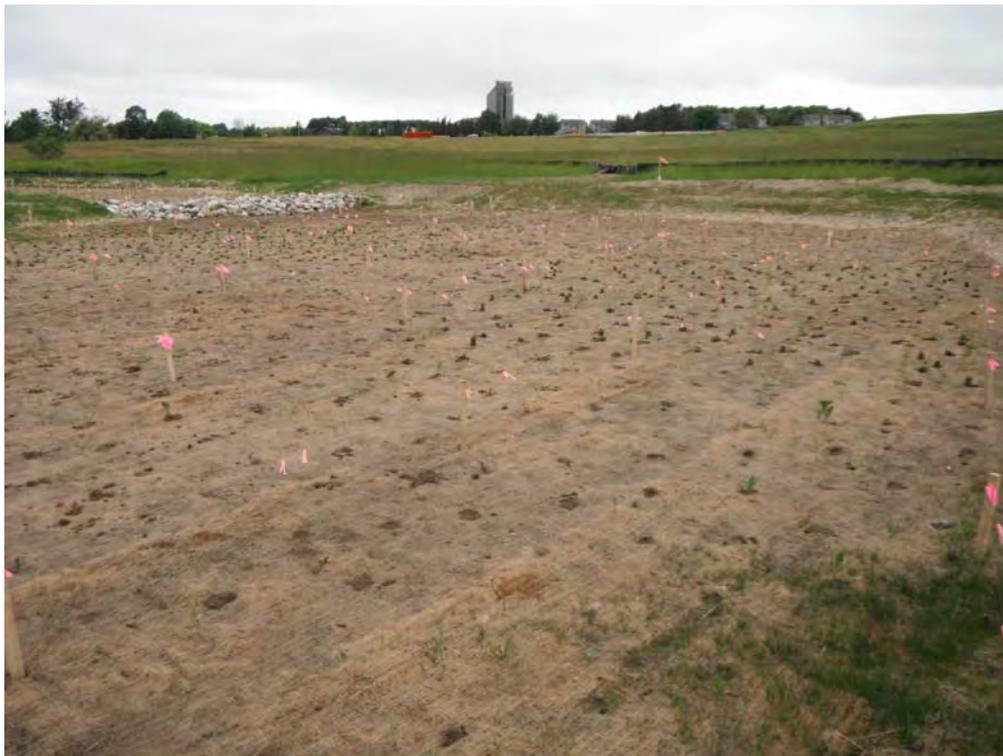
This basin appears to be receiving water from precipitation and is saturated (Photo 14). Inundation occurs along the low head rock berm between Basin 2A and 2B (Photo 15). The plants (Photo 16) in this basin are stressed and have been grazed by wildlife (deer and/or waterfowl). The open holes absent of plugs are evidence of wildlife herbivory. The entire depression has been planted with plugs. The plants in the plant list that were observed include three-square bulrush, lake sedge, arrowhead, water plantain, and dead river bulrush.

Photograph No. 14. Basin #2A. Facing north.

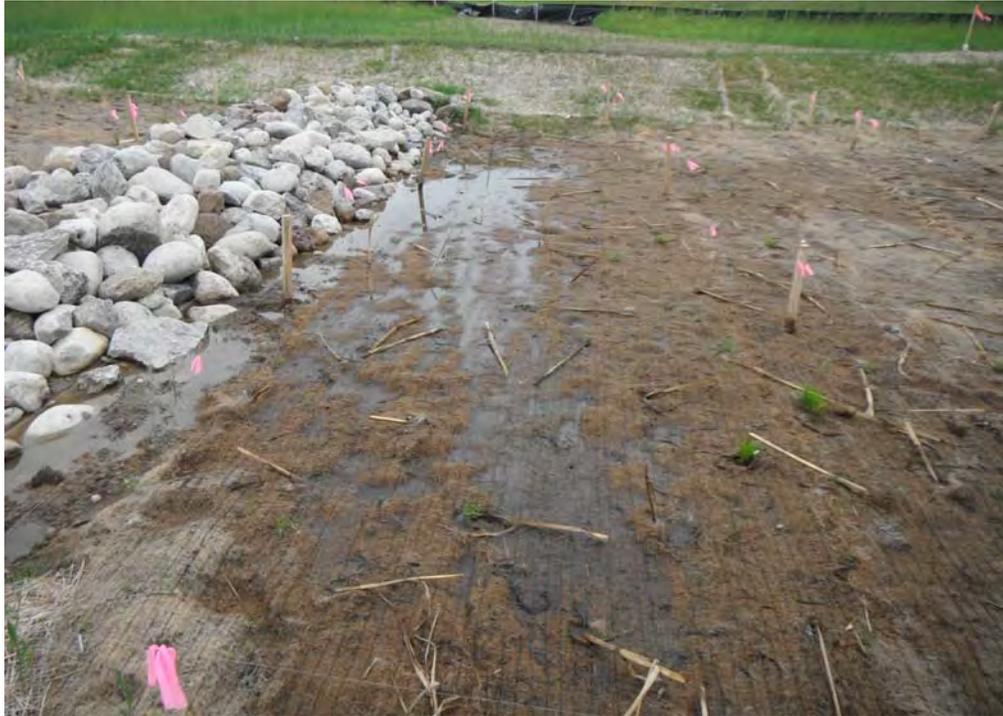
Photograph No. 15. Basin #2A. Inundation.

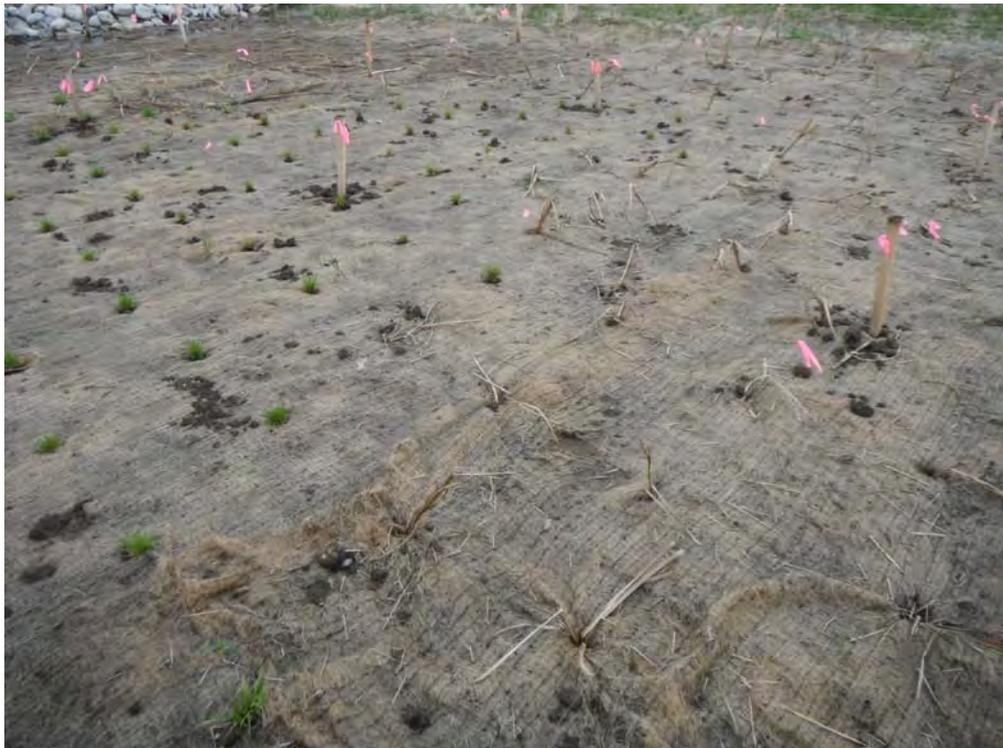
Photograph No. 16. Basin #2A. Stressed/dead plants.

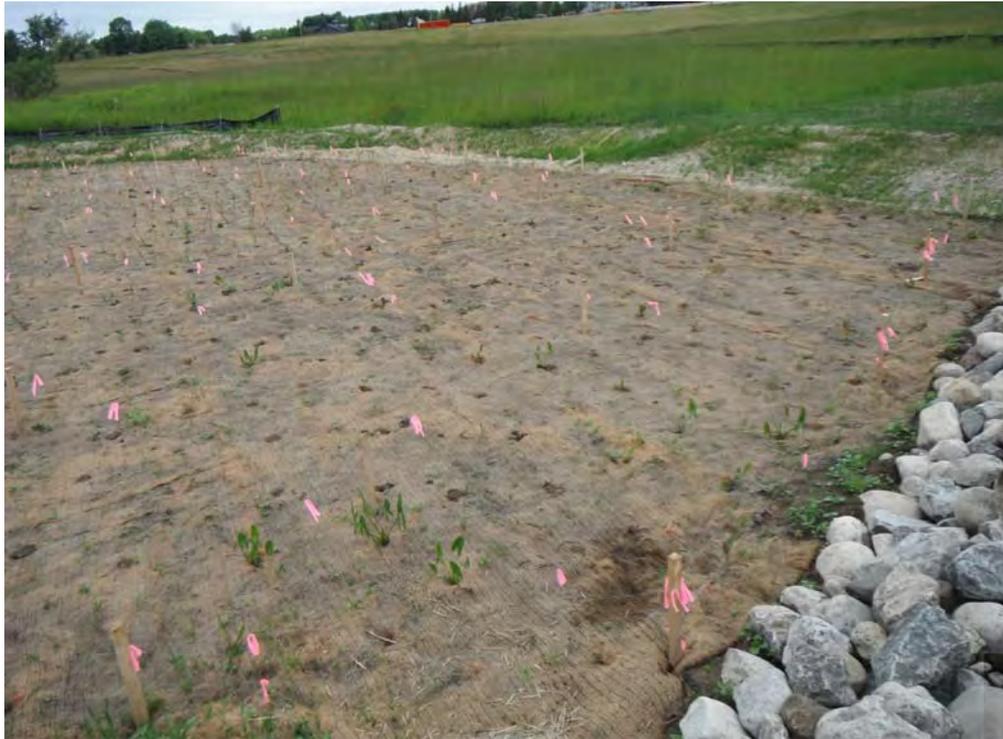
The water overflowing the low head rock berm between Basin 2A and 2B flows into Basin 2B. The hydrology in Basin 2B is dry to saturated (Photo 17). It does not appear that it receives much water from Basin 2A. There appears to be approximately 25% mortality among the arrowhead and water plantain plantings (Photo 18). River bulrush appears to have approximately 75% mortality. Lake sedge appears to be doing well. The design of Basin 2B indicates that water will overflow a low head berm and flow through a swale to a natural wetland adjacent to a stream (Photo 19). The swale appears to be well vegetated and no sediment is entering the natural wetland. There is some debris in the swale that should be removed (Photo 20).

Photograph No. 17. Basin #2B. Facing NW.

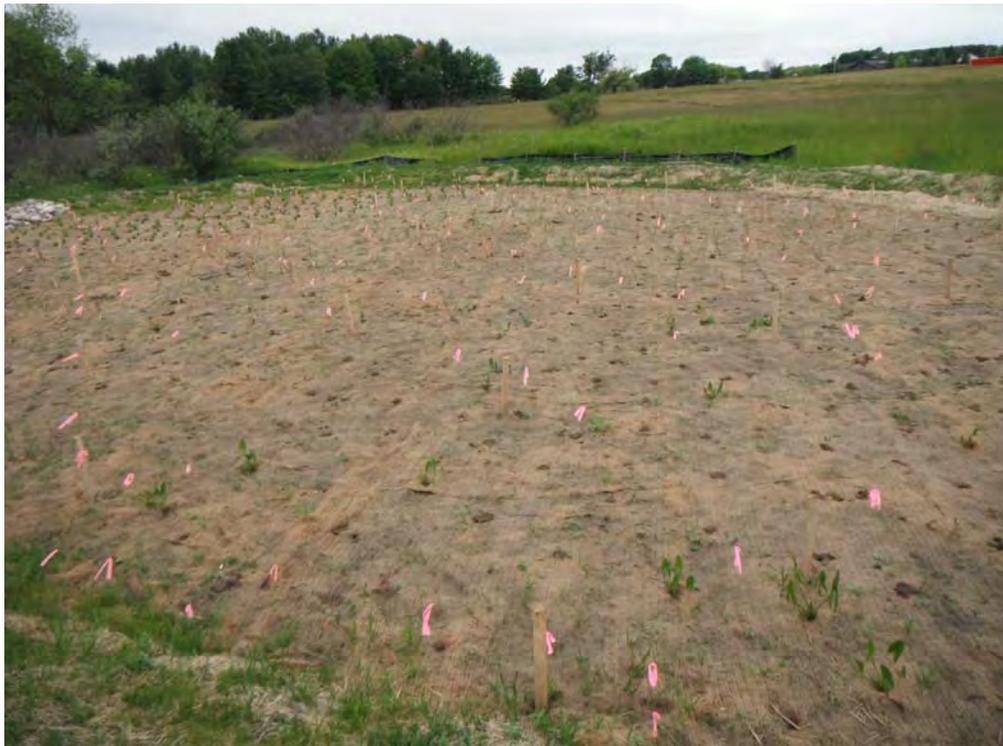
Photograph No. 18. Basin #2B. Facing west.

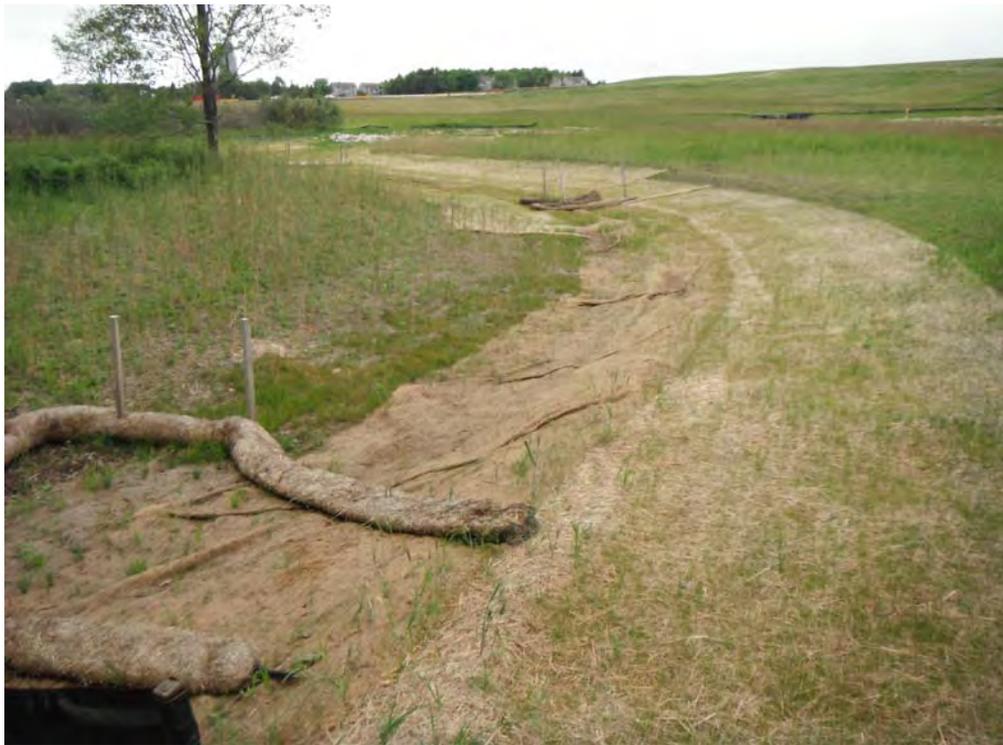
Photograph No. 19. Basin #2. Discharge swale to stream.

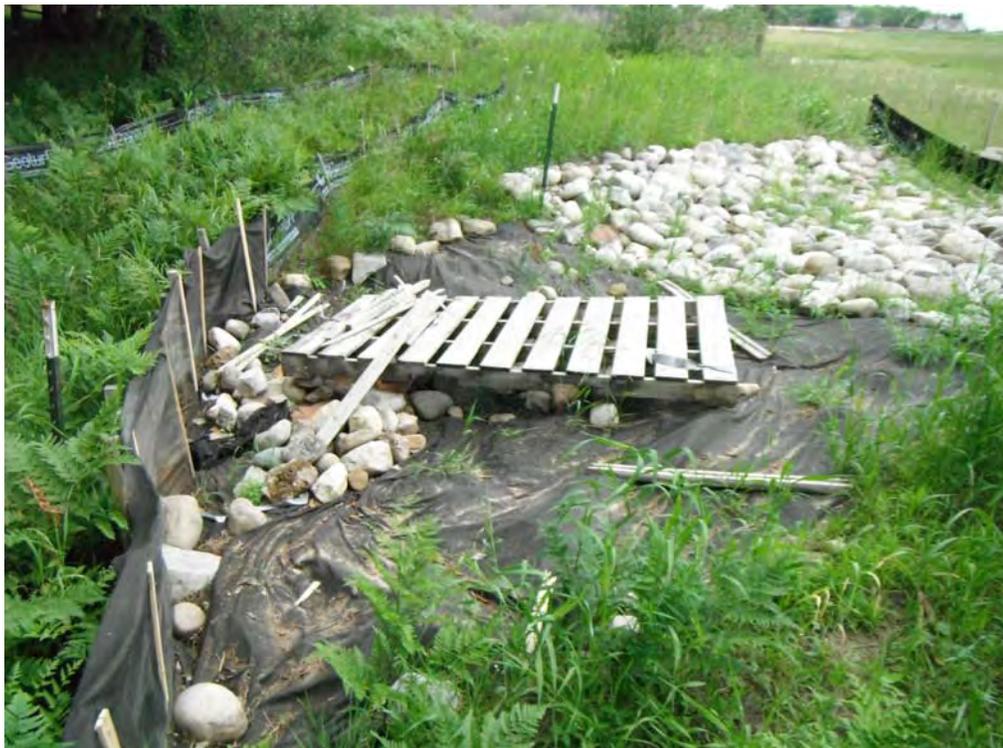
Photograph No. 20. Basin #2. Discharge swale. Remove debris.
