February 13, 2015

Re: **Response to January 29, 2015
Notice of Violation VN-005987 (“NOV”) Addressing Storm Water
Runoff and Track-Out at Grand Traverse Town Center Site**

Exhibit A

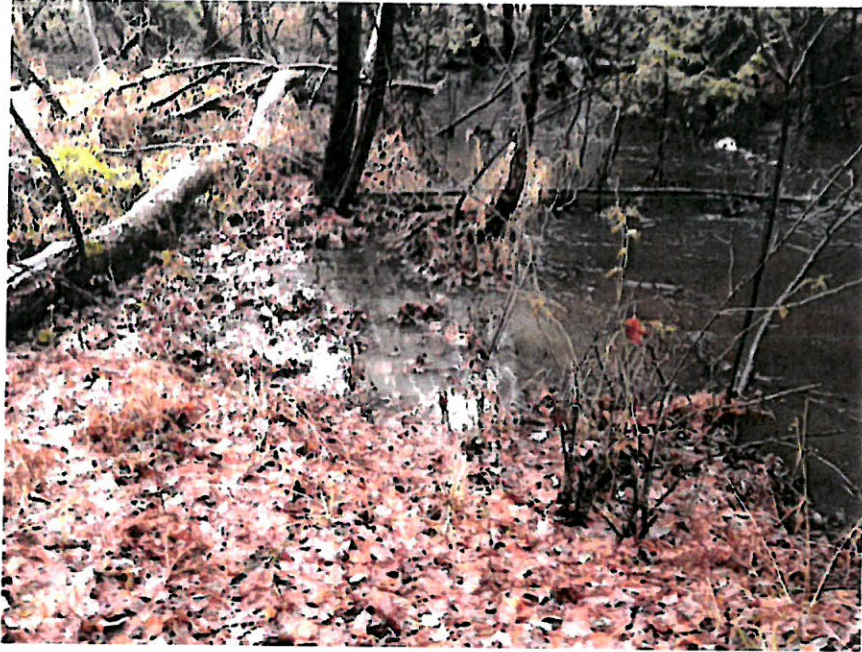
Photograph No. 1: Acme Creek north of Basin 2 Swale Outlet (11/24/14)

VGT Response: The water entering the creek was slightly turbid in this location (see Photos #1 and #2, attached in Exhibit A, taken at the time of the inspection). Mike Potter characterized this water as slightly turbid, not sediment-laden, and noted that any turbidity dissipated within 10 feet of entry into the creek. This de minimis condition is clearly documented in the attached photographs. You and Mike Potter agreed that the stream did not look any more turbid downstream of the Site at M-72 than it did upstream of the Site (see Department Inspection Form Photos #3 and #4, attached in Exhibit A).

⁵ The presence of foreign footprints was observed along the bank in the exact location of the alleged discharge indicating that there had been someone traversing the bank in this area prior to the inspection. Given the consistency of the clay soils along the creek bank, this foot traffic likely generated the observed small quantity of turbid discharge entering the creek, since there is no clear visual evidence of channelized discharge evident in attached photographs 1 and 2.

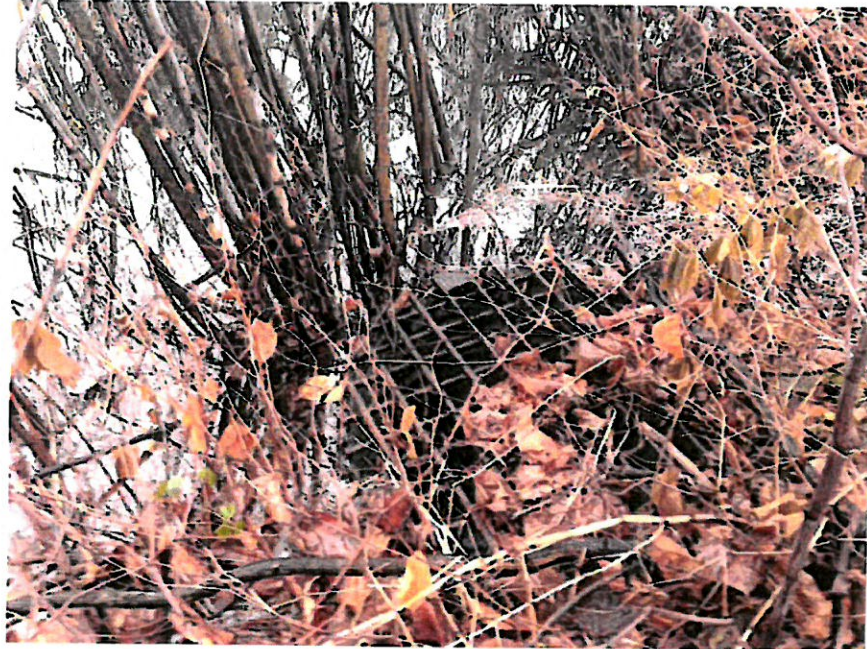
Photograph No. 6: Dinner Theatre storm water pond outlet structure (11/24/14)

Additionally, you and Mike Potter inspected the outlet from the retention pond on the dinner theater parking lot (see Photo #6, attached in Exhibit A). This outlet discharges to a ditch along M-72, which then drains to Acme Creek. Mike Potter observed the water exiting the pond at the outlet structure to be visibly clear. Mr. Potter noted your concurrence in his notes, although this observation does not appear to be recorded in your notes.
