Re: **Village at Grand Traverse Response to October 21, 2014
Notice of Violation VN-005944 (“NOV”) Addressing Stormwater
Runoff**

CORRECTIVE ACTION PLAN

**STORM WATER DISCHARGE FROM
CONSTRUCTION ACTIVITIES**

**GRAND TRAVERSE TOWN CENTER SITE
4900 EAST M-72
ACME TOWNSHIP
GRAND TRAVERSE COUNTY, MICHIGAN**

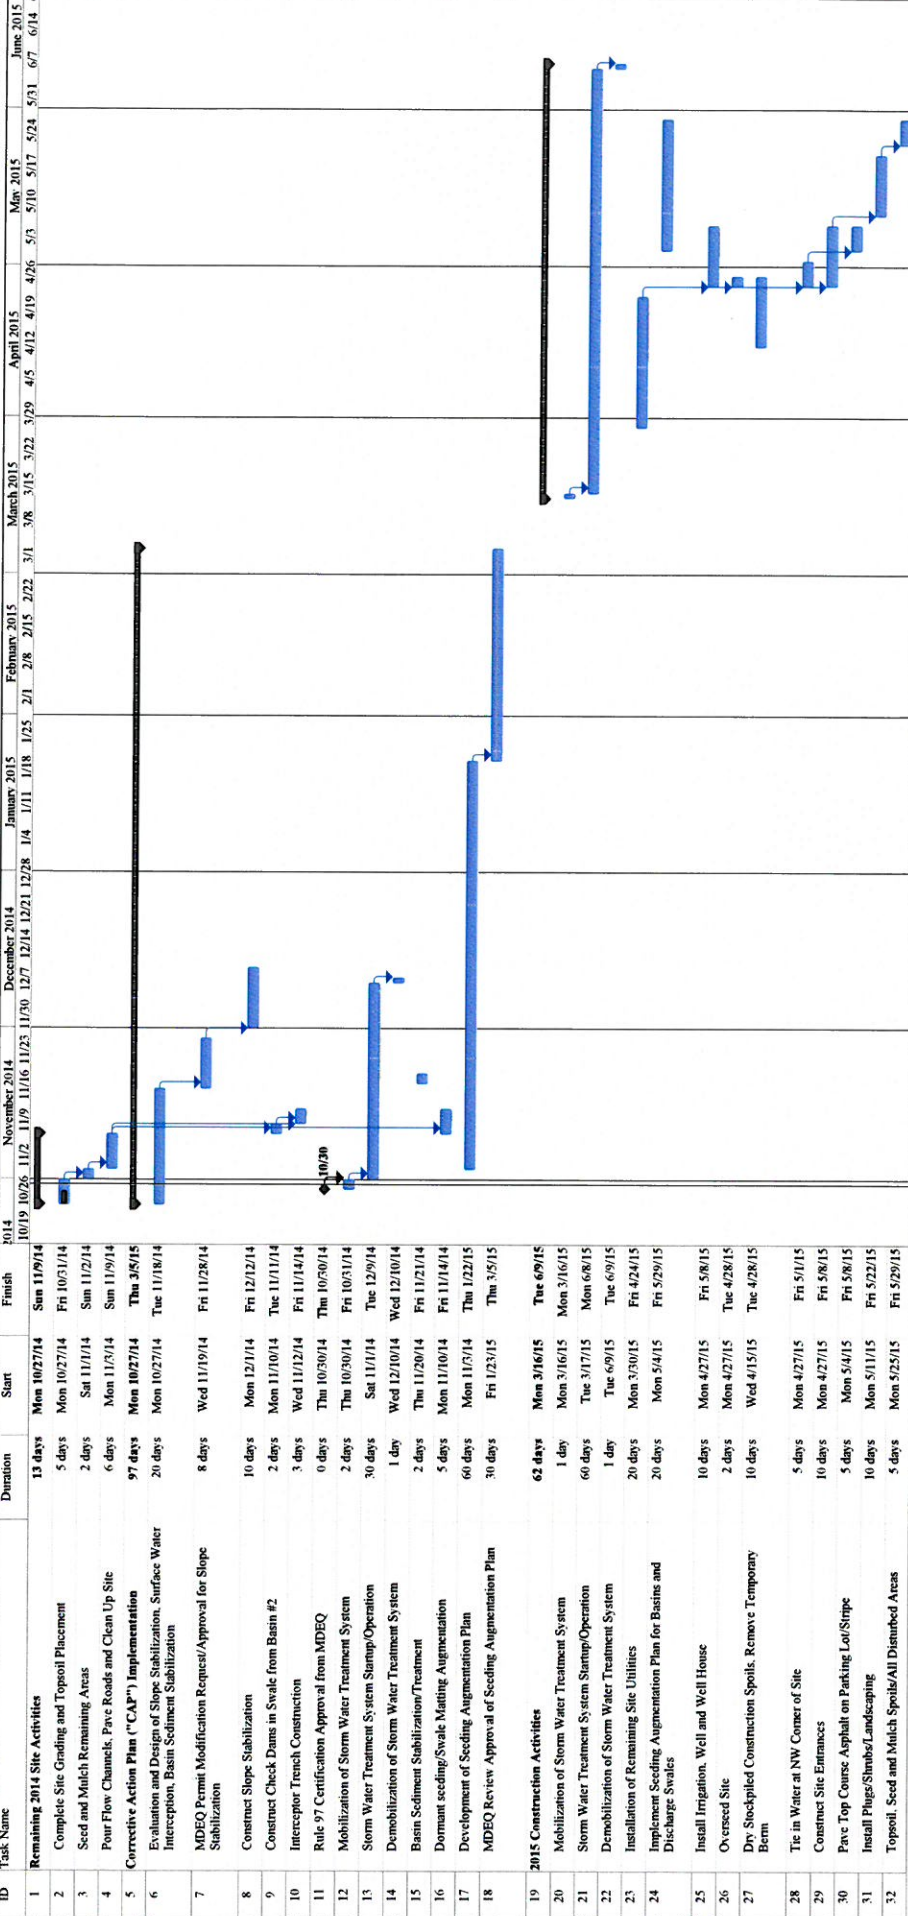
Figure 1
Grand Traverse Town Center
Construction/Storm Water CAP Implementation Schedule

ALL DATES/DURATIONS ARE APPROXIMATE AND WEATHER DEPENDENT

A proposed implementation schedule for the corrective actions outlined herein is presented as Figure 1. As noted on Figure 1, implementation schedules for these activities, particularly those to be implemented in the spring of 2015, are highly weather dependent and the actual schedule may vary from that presented on Figure 1. VGT will provide the MDEQ with periodic updates regarding any such schedule variations.

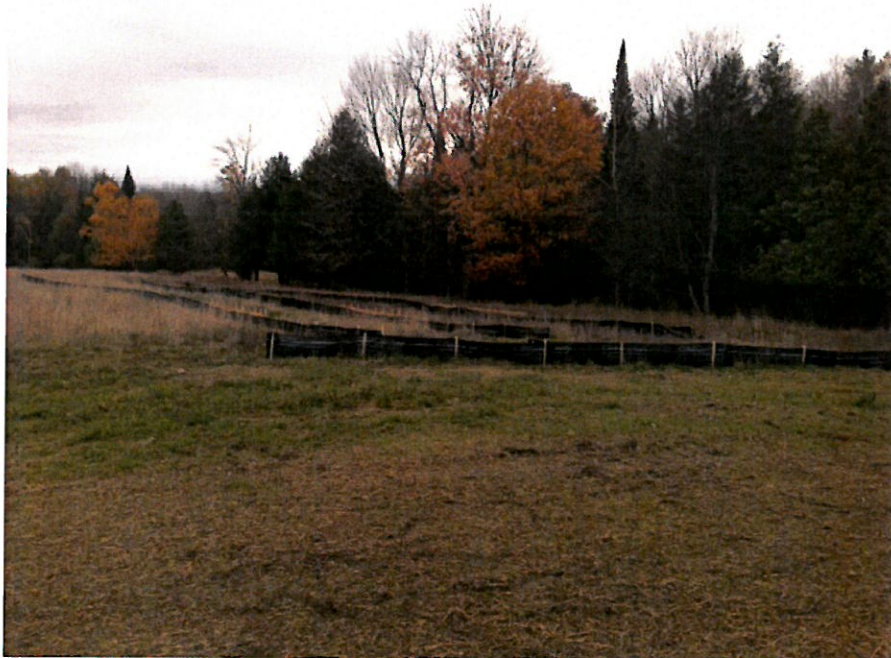
Photograph No. 1

Multiple Rows of Silt Fence Near Swale 2 Discharge, October 27, 2014
Photo Credit: M. Potter, Horizon Environmental

1. Provide two additional rows of silt fence south of the discharge swale from Basin #2. **(Completed 9/23/14)**
2. Install two additional rows of silt fence north of the discharge swale from Basin #2. **(Completed 9/23/14)**
3. Install one additional row of silt fence 10 to 15 feet south of the existing silt fence at the MDEQ-approved wetland road crossing. **(Completed 9/23/14)**
4. Provide two additional rows of silt fence on the west side of the property and one additional row of silt fence on the south side of the property **(Completed 9/22/14)**
5. Construction of temporary berms to reduce/prevent runoff from disturbed areas of the site, including a large temporary bermed area north of the site corridor road, where storm drains were plugged, allowing this area to function as a storm water impoundment.
6. Installation of straw wattles and fiber wattles in discharge swales.

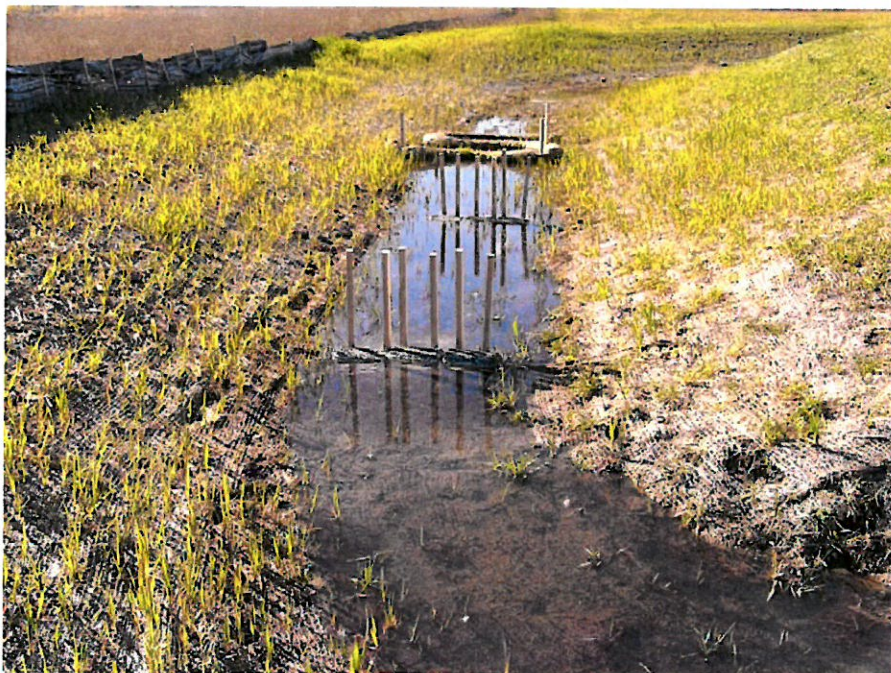
Photograph No. 2

Polyacrylamide (“PAM”) Flocculant Blocks and Wattle in Basin 1 Swale, October 25, 2014
Photo Credit: C. Grobbel, from www.acmefuture.org

- Damaged silt fences observed during Mr. Bragg's inspection were repaired (**Completed 10/2/14**);
- Additional PAM blocks were placed in the discharge swales from Basins 1 and 2 to improve retention of sediment on the property (**Completed 10/3/14**);

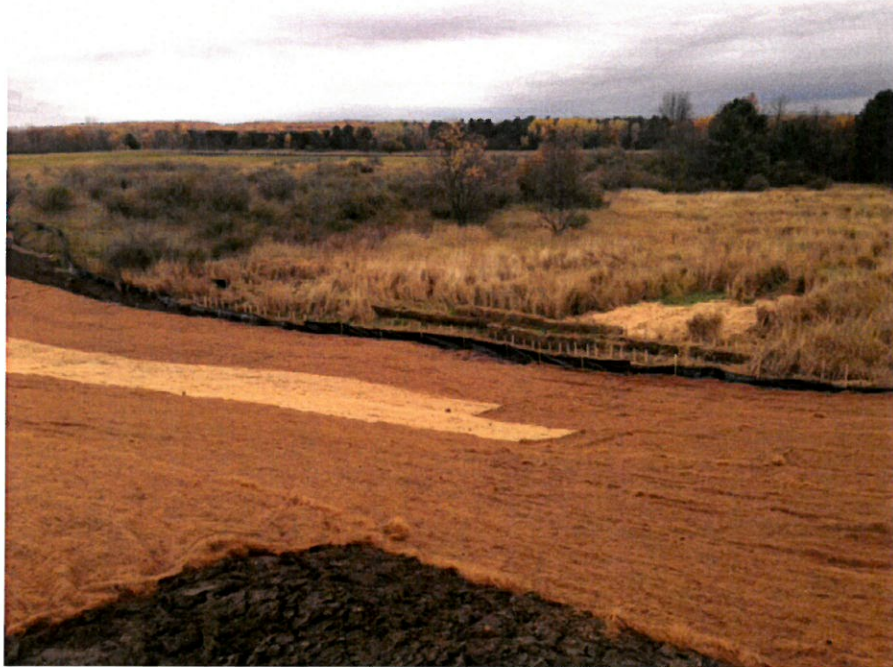
Photograph No. 3

Topsoil, Seeding and Mulch Matting at Slope South of Corridor Road, October 27, 2014
Photo Credit: M. Potter, Horizon Environmental

Construction of the site corridor road involved MDEQ permitted placement of fill in a regulated wetland and related grading of a slope immediately south of the corridor road. As noted in the MDEQ's October 10, 2014 correspondence to VGT, rainfall events in October of 2014 resulted in erosion of this slope and discharge of sediment to the adjacent wetland. This sediment was removed from the wetland in October of 2014 and the slope was stabilized via seeding and placement of mulch matting.

To reduce the potential for further erosion in this area, more robust stabilization of this slope is proposed. The area of proposed slope stabilization is depicted on the site plan presented as Attachment I. Slope stabilization will likely be accomplished via placement of geotextile fabric overlain by 8-12 inch riprap. The specific nature of the slope stabilization has not been established at this time. Geotechnical conditions in this area, other engineering considerations or wetland considerations may necessitate that alternative methods (e.g., shotcrete, concrete gabions) of slope stabilization be employed. Final techniques will be established in an amendment to the site's MDEQ permit for wetland construction activities.

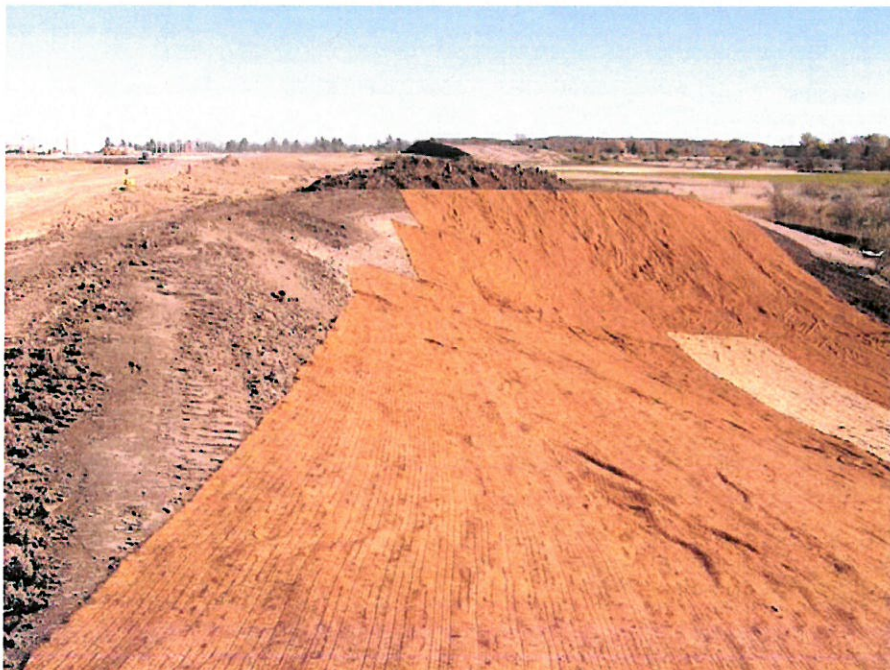
Photograph No. 4

Topsoil and Erosion Control Matting Near South Slope, October 25, 2014
Photo Credit: C. Grobbel, from www.acmefuture.org

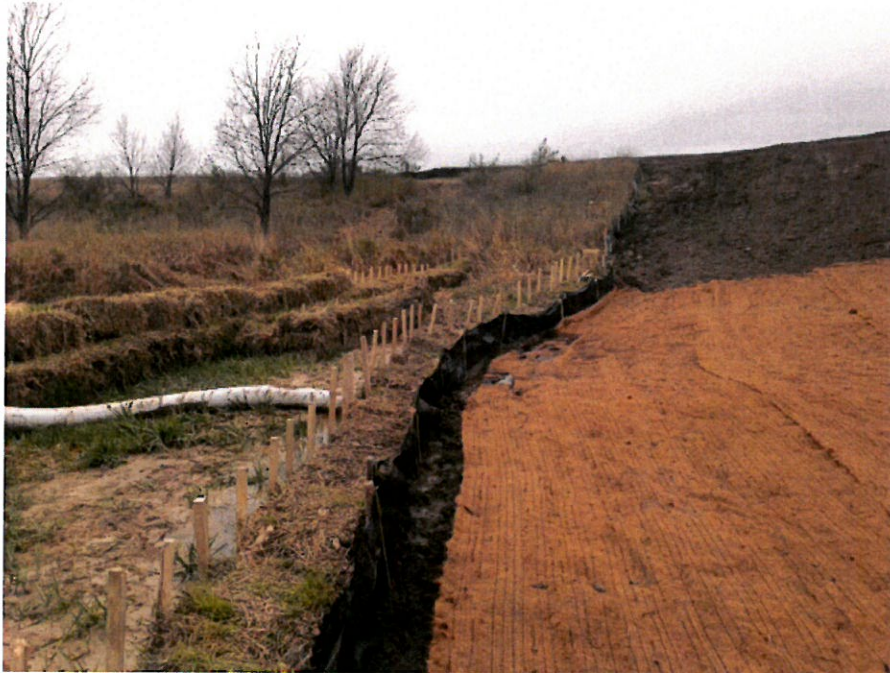
Photograph No. 5

Perimeter Silt Fencing and Hay Bales, October 24, 2014
Photo Credit: M. Potter, Horizon Environmental

1. Placement of stacked hay bales along the silt fence on the south side of the property **(Completed 6/17/14)**.
2. Installation of additional silt fence at the discharge swale from Basin #1. **(Completed 6/19/14)**.

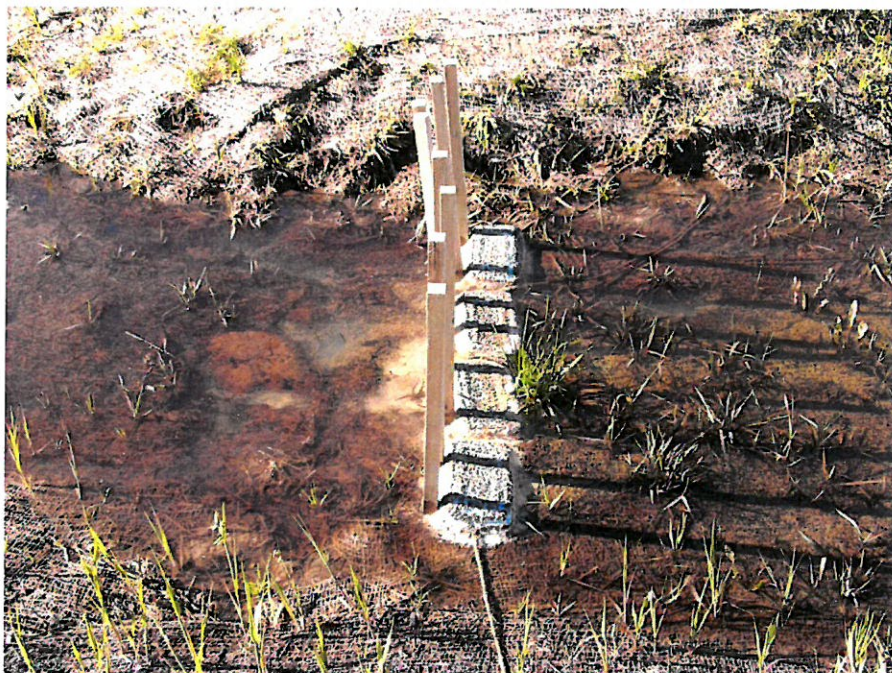
Photograph No. 6

PAM Flocculant Blocks in Basin 1 Discharge Swale, October 25, 2014
Photo Credit: C. Grobbel, from www.acmefuture.org

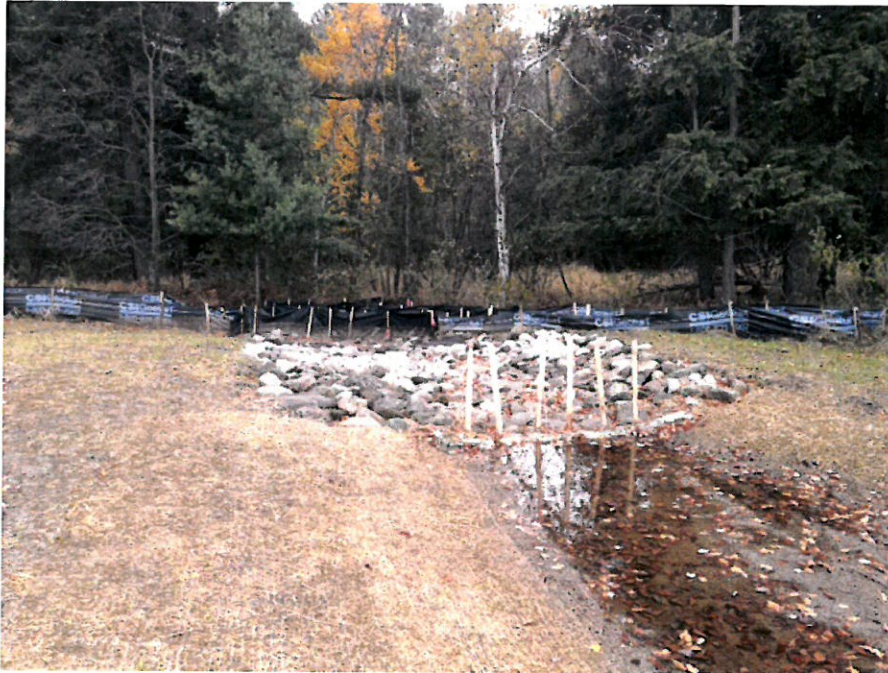
Photograph No. 7

Riprap Apron, PAM Flocculant Blocks and Silt Fence at Basin 2 Discharge, October 27, 2014
Photo Credit: M. Potter, Horizon Environmental

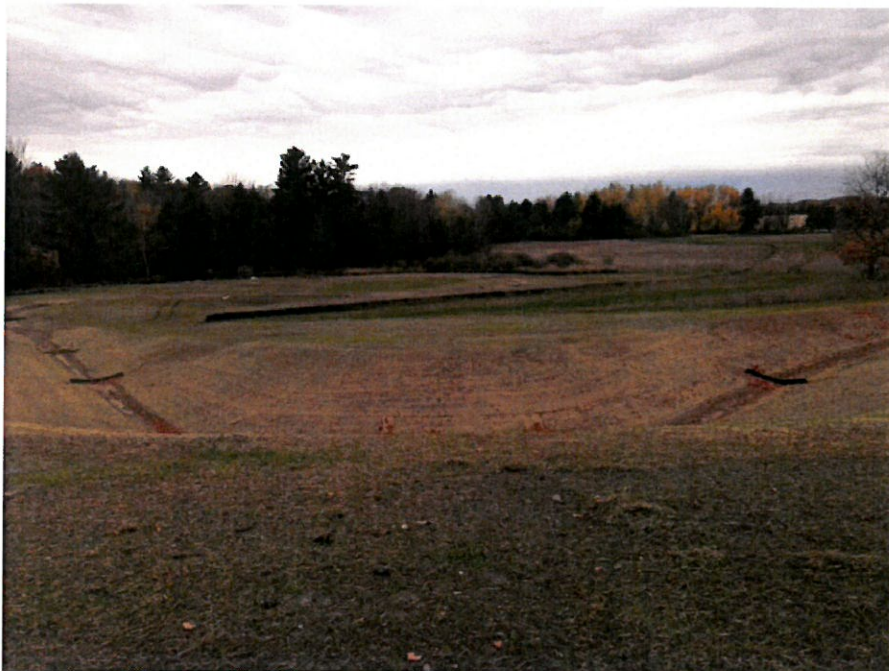
Photograph No. 8

Stabilized Discharge Swale from Basin 2 with Velocity Reducers, October 27, 2014
Photo Credit: M. Potter, Horizon Environmental

Riprap check dams are proposed to be constructed in the drainage swale from Basin #2 to replace existing velocity reducers previously placed in the swale. The riprap check dams will be constructed in a manner similar to riprap check dams constructed elsewhere on the property (e.g., the swale immediately south of Basin #2).

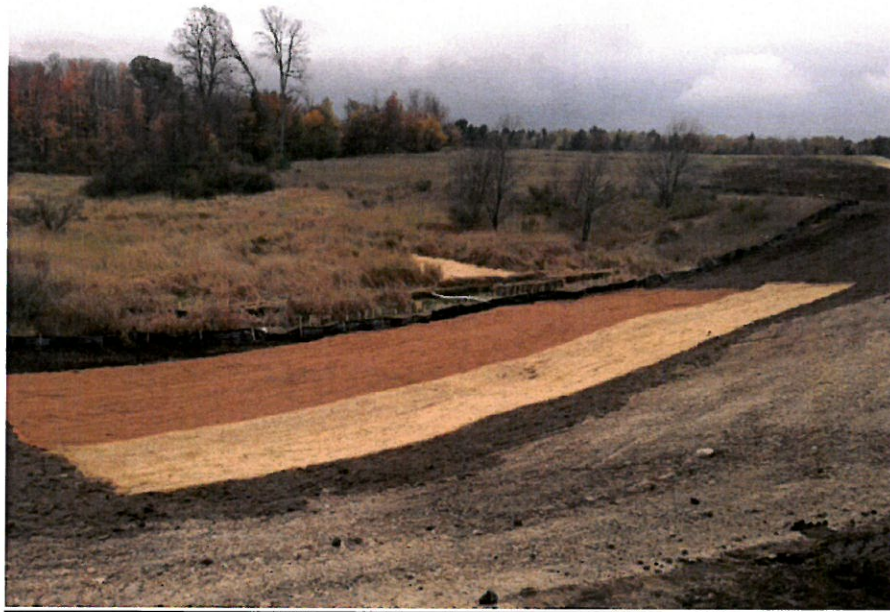
Photograph No. 9

Topsoil, Seeding and Mulch Blanket at Southern Extent of Grading, October 27, 2014
Photo Credit: M. Potter, Horizon Environmental

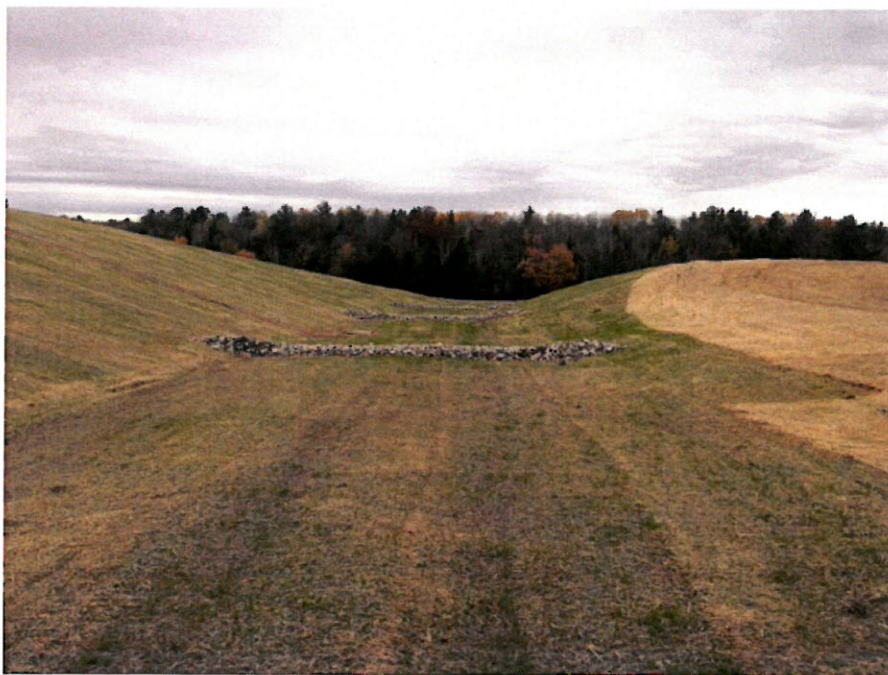
Photograph No. 10

Stabilized Drainage Swale and Riprap Check Dams South of Basin 2, October 27, 2014
Photo Credit: M. Potter, Horizon Environmental

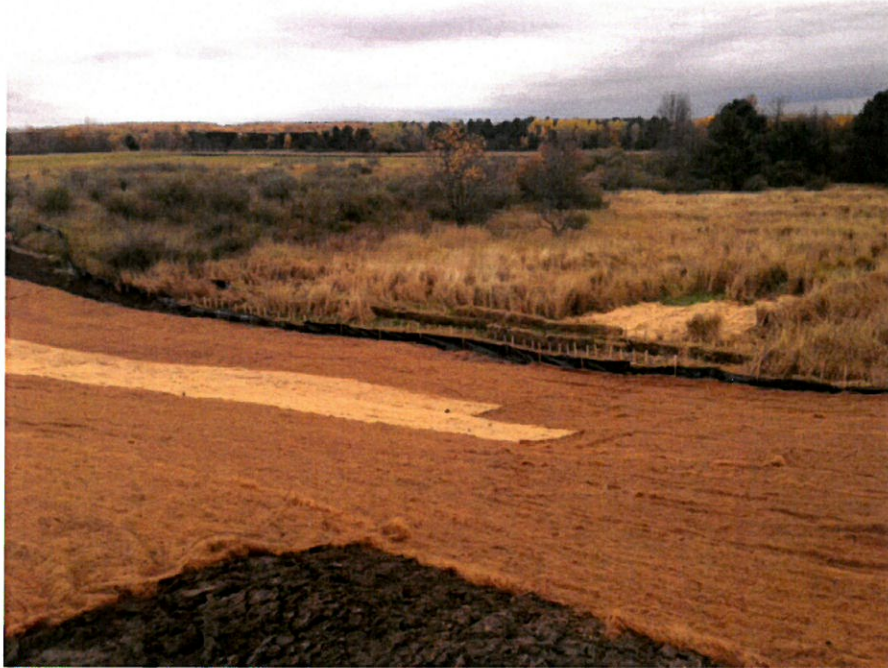
Photograph No. 11

Topsoil, Seeding and Mulch Matting at Slope South of Corridor Road, October 27, 2014
Photo Credit: M. Potter, Horizon Environmental

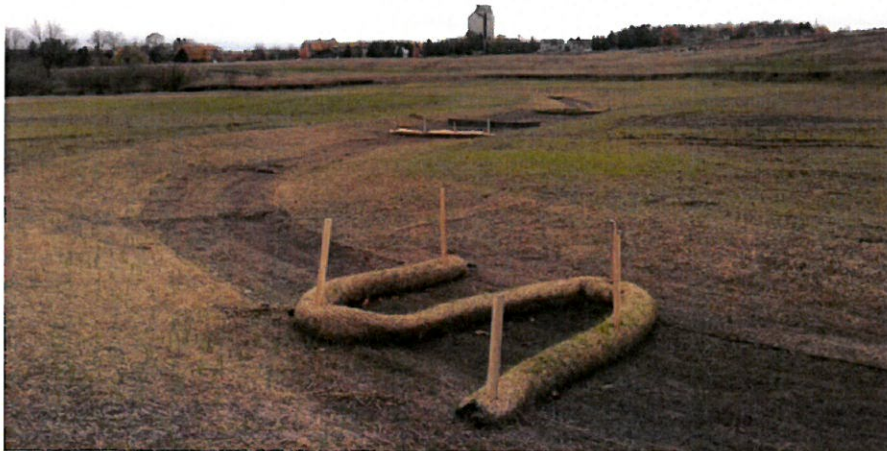
Photograph No. 12

Wattles & Velocity Reducers in Basin 2 Swale, October 27, 2014
Photo Credit: M. Potter, Horizon Environmental

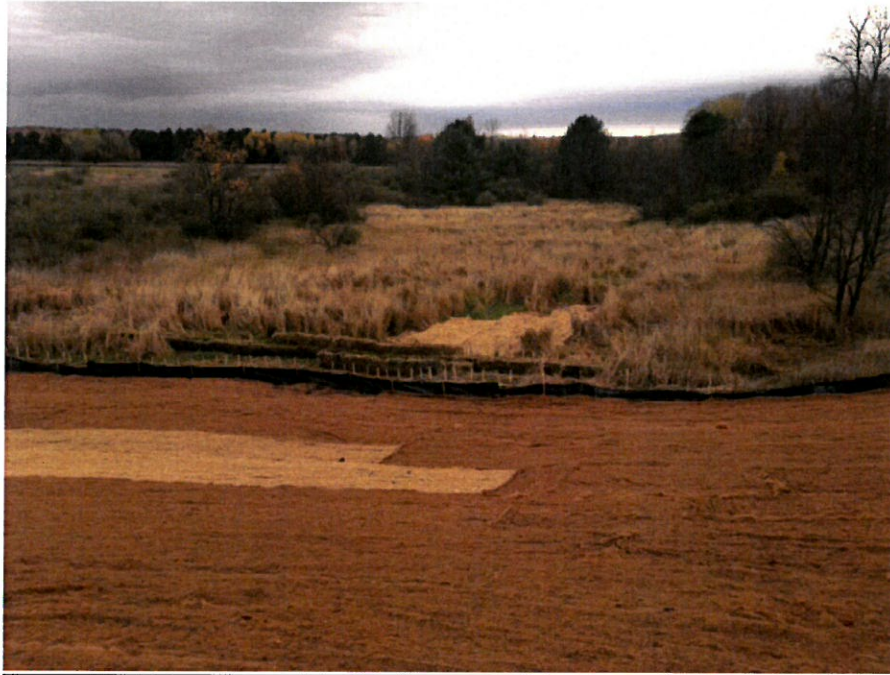
Photograph No. 13

Topsoil, Matting, Silt Fence and Wetland Restoration at South Slope, October 27, 2014
Photo Credit: M. Potter, Horizon Environmental

During the storm event of October 2 and 3, sediment was observed to have eroded from the bank south of the site corridor road into the adjacent wetland. Approximately 1 cubic yard of sediment accumulation within and upslope of the wetland was removed using a small tracked excavator on October 22 and 23, at such time as the ground surface had dried sufficiently to support these work activities. The material was placed in a secure upland location and the slope where erosion occurred was restored via placement of seeding and coconut mulch blanket.

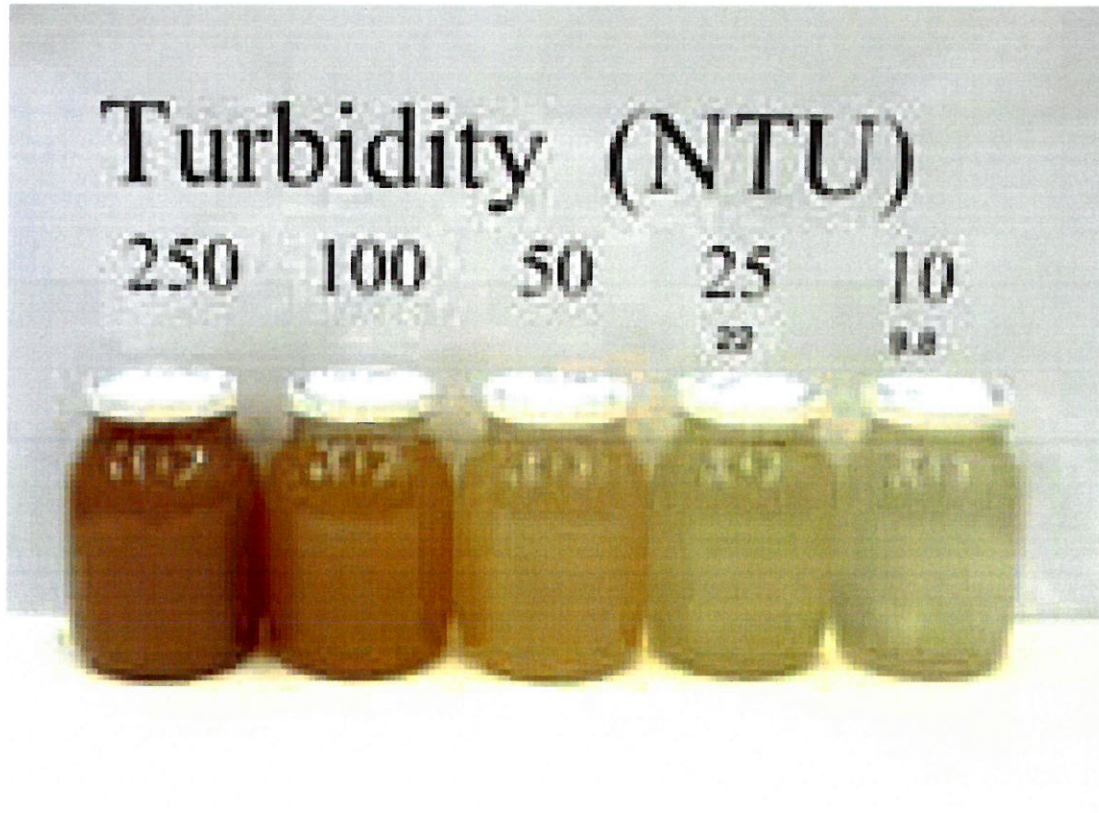
ATTACHMENT 2

¹ “NTU” stands for “Nephelometric Turbidity Units.” As the photograph in Attachment 2 to this response illustrates, a discharge of 280 NTUs would represent substantially turbid water that is comparable to the turbidity in runoff observed at the Site. (The attached photograph was taken from a website called “Ohio Environmental Law Blog.” While VGT cannot vouch for the accuracy of the samples depicted relative to the NTU levels shown, the picture still illustrates the point that even under the rule EPA withdrew, allowable turbidity in discharges would have been significant.)
